Rusling Hose Company
Fire Engine #13
13 Rennie Street, Hamilton, NJ 08610

Feasibility Study

December 7, 2017

Fire Station # 13, Rusling District 3 – Audit

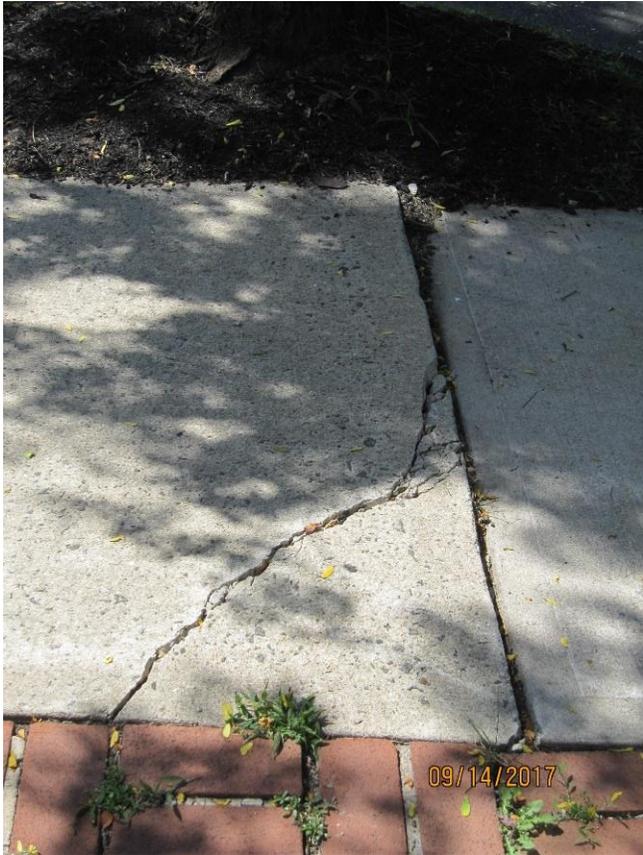
- E. There are designated parking lot and street barrier free parking spaces.
- F. The station has barrier free entrances.
- G. There are 4 locations along the concrete sidewalk on Chambers Street where a section of the sidewalk has heaved and are higher than the adjacent sidewalk sections. This is most likely caused by the roots of the adjacent tree running under the sidewalk. There are 5 locations along the concrete sidewalk on Rennie Street where a section of the sidewalk has slightly heaved and are higher than the adjacent sidewalk sections.

SEVERE CRACKS IN THE SIDEWALK

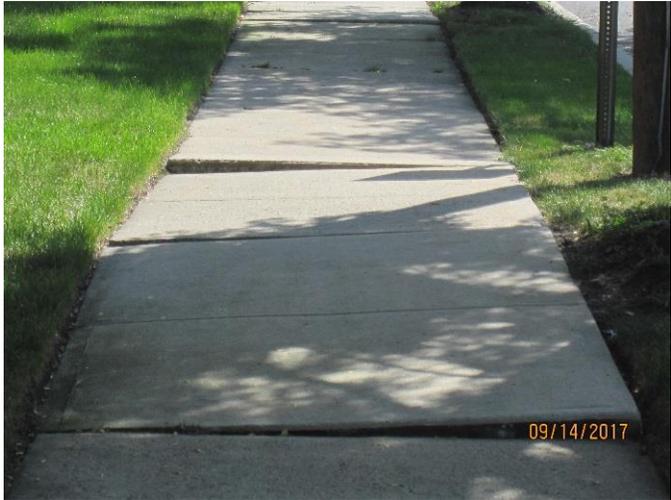
VISIBLE SETTLEMENT IN THE SIDEWALK
CREATING A TRIPPING HAZARD

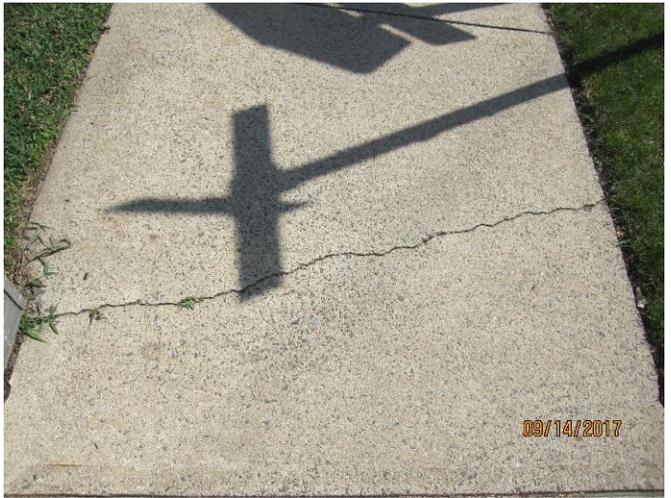
VISIBLE CRACKS IN THE SIDEWALK

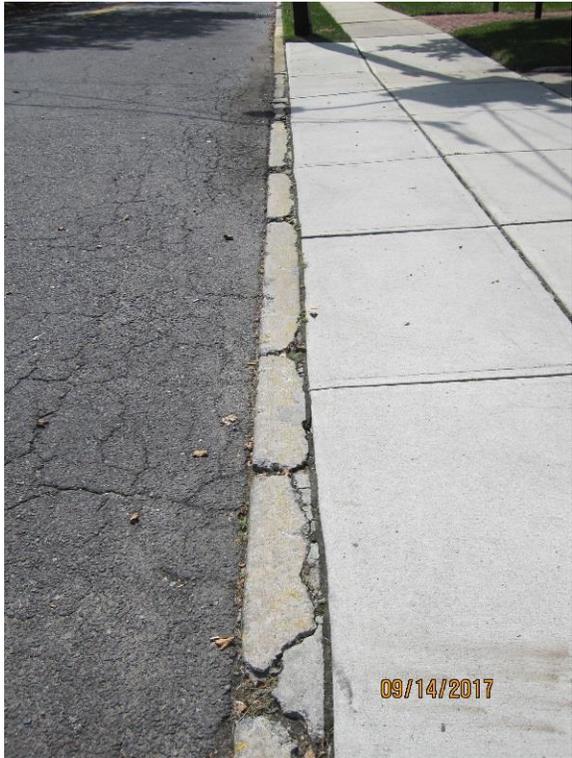
- A. The station has adequate fire truck maneuverability and turn-around space.
- B. The concrete apron at the truck entrance is in good with only one minor crack. However the concrete curb located between the apron and street is in poor condition containing many spalls and cracks in the concrete. There are several locations on the apron where vegetation growing within the concrete joints.

VISIBLE CRACKS IN THE CURB

<u>Work Item</u>	<u>Estimated Cost Opinion</u>
A. <u>Site</u>	
i. Repair crack in concrete apron at the truck entrance	\$3,500
ii. Replace concrete curb along street at the truck entrance	\$9,000
iii. Reseal the concrete apron joints.	\$4,500
iv. Replace concrete apron at parking lot entrance	\$12,000
v. Remove large tree roots located under the heaved and replace 9 sections of concrete sidewalk	\$4,500
vi. Repoint mortar joints of brick pavers	\$9,000
vii. Replace brick pavers	\$2,500

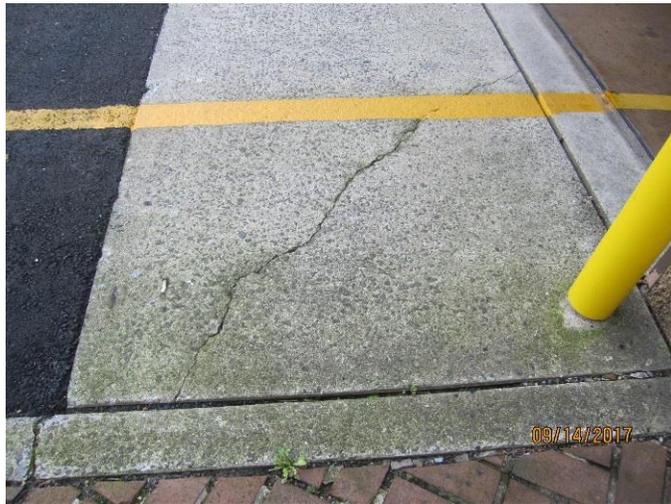
VISIBLE CRACKS IN THE SIDEWALK

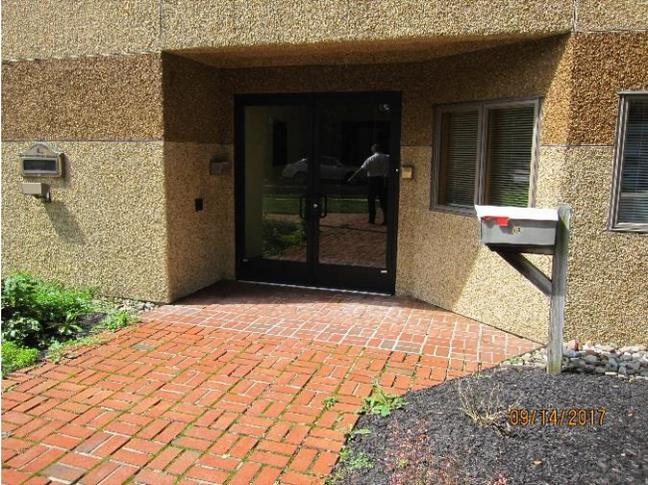
- H. There are several locations within the brick paver areas where the brick mortar joints require repointing and several bricks require replacement.

GROUT HAS ERODED AND SIGNS OF MOSS GROTH IN THE BRICK PAVERS

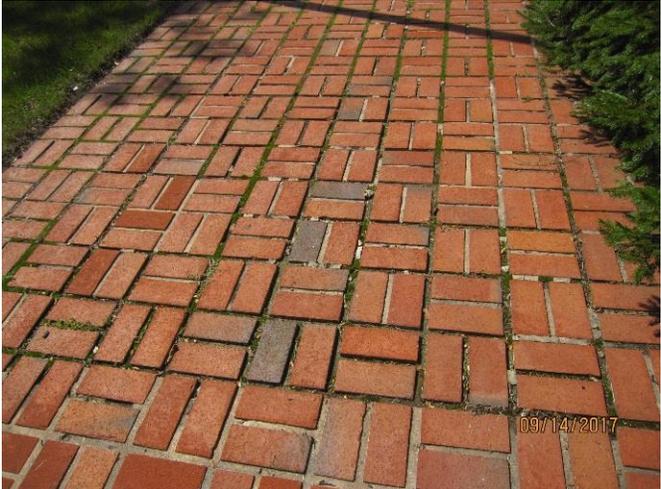
GROUT HAS ERODED AND MISSING IN SOME AREAS OF THE BRICK PAVERS

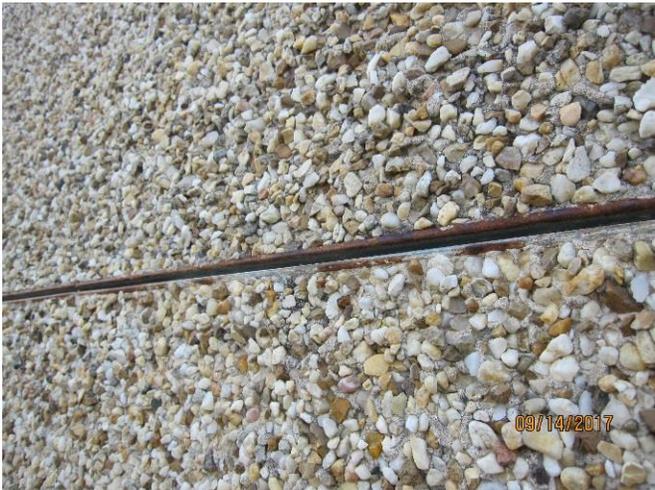
- iv. The overhead truck bay doors all operate properly and are in fair condition.
 - v. There are some locations where the steel divider strips between the exposed aggregate panels are rusting.

VISIBLE RUST IN METAL EXPANSION JOINT

B. <u>Facades</u>	
i. Reseal around the perimeter of existing windows	\$6,500
ii. Option 1-Replace aluminum awing windows	\$180,000
iii. Replace the hollow metal door & frame at generator room	\$3,000
iv. Remove the rust from the steel divider strips	\$6,000

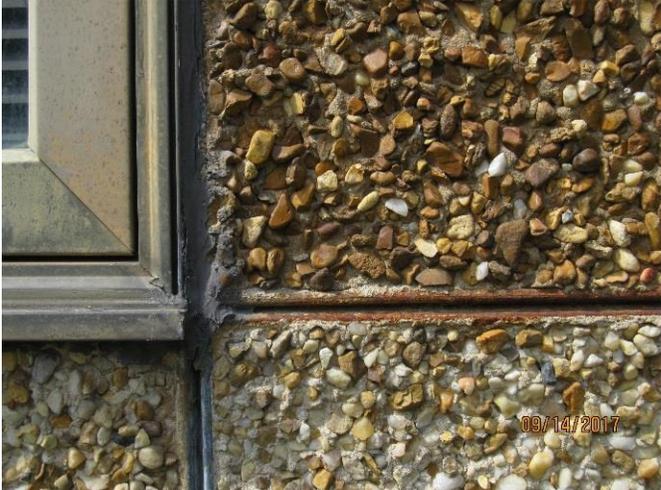
- v. There are some locations where the steel divider strips between the exposed aggregate panels are rusting.
- B. Roofs
 - i. A single ply membrane roofing system and base flashings are located on the various roofs are original and in poor condition, several areas have either been patched or replaced. These roofs have exceeded its life expectancy.

VISIBLE RUST IN METAL EXPANSION JOINT

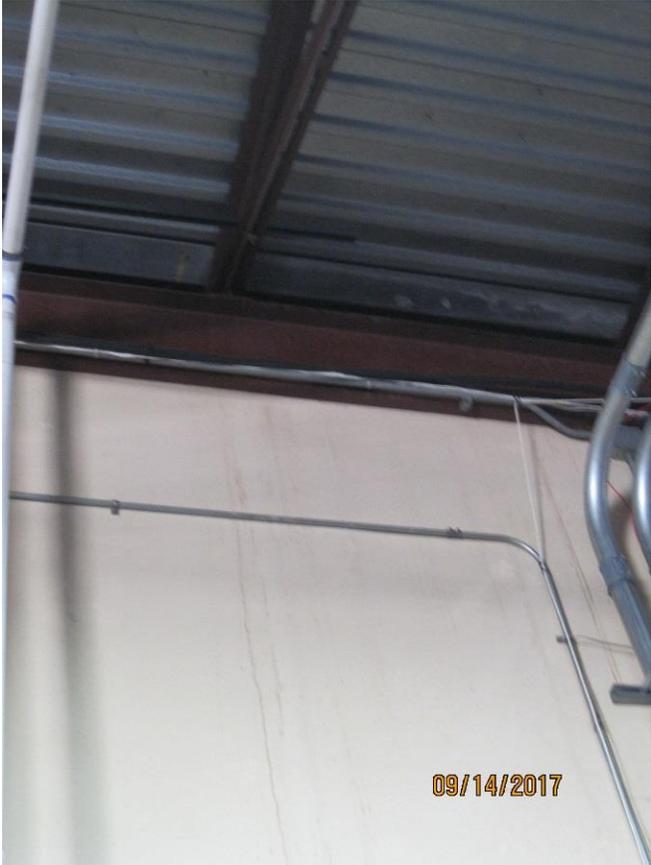
- ii. These roofs are exhibiting water infiltration, especially during a wind driven rain at the base of the second floor wall adjacent to the lower roof.

SIGNS OF WATER LEAKEAGE ON THE WALL

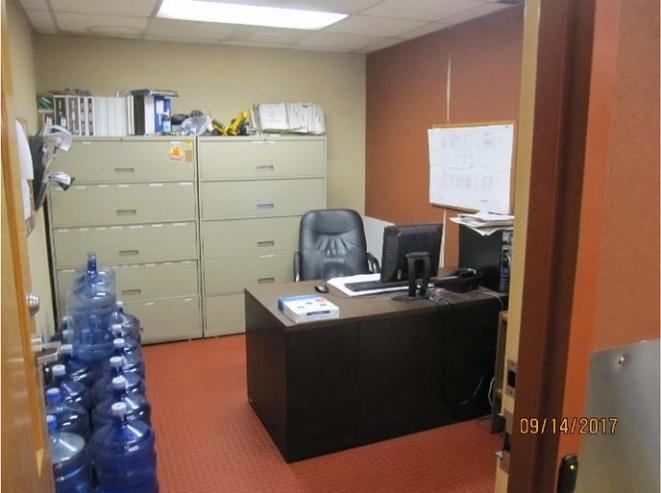
SIGNS OF WATER LEAKEAGE IN THE CEILING AND DAMAGE TO THE WALLPAPER

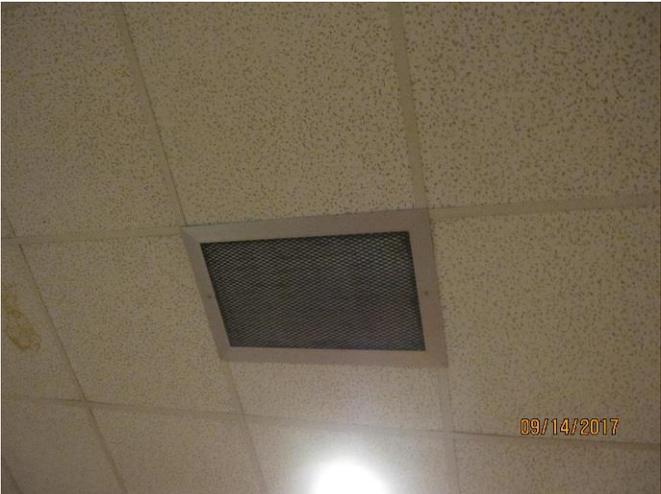
SIGNS OF WATER LEAKEAGE IN THE CEILING

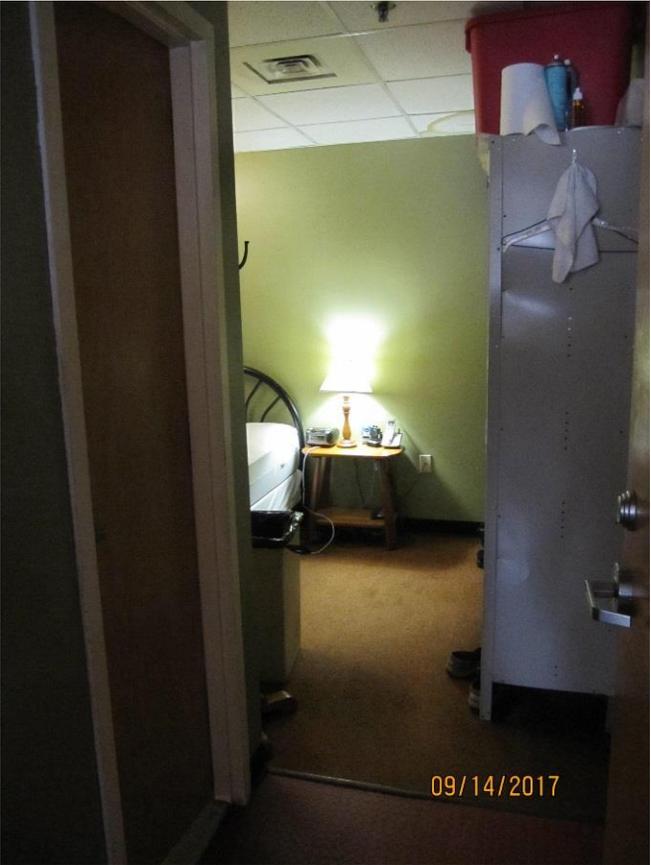
SIGNS OF WATER LEAKEAGE IN THE CEILING

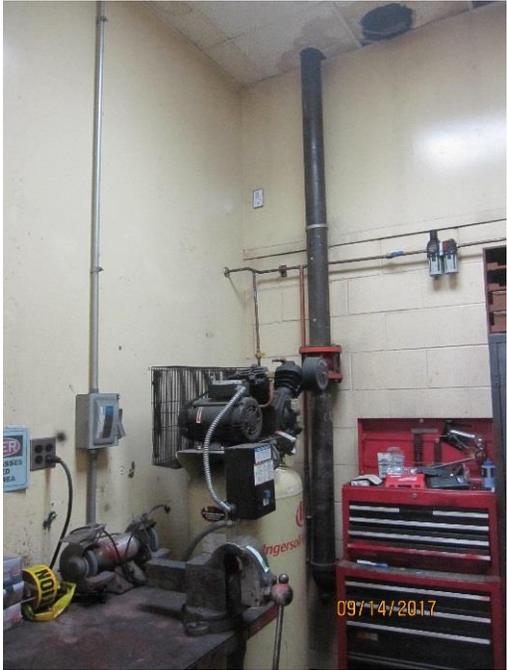
SIGNS OF WATER LEAKEAGE IN THE CEILING

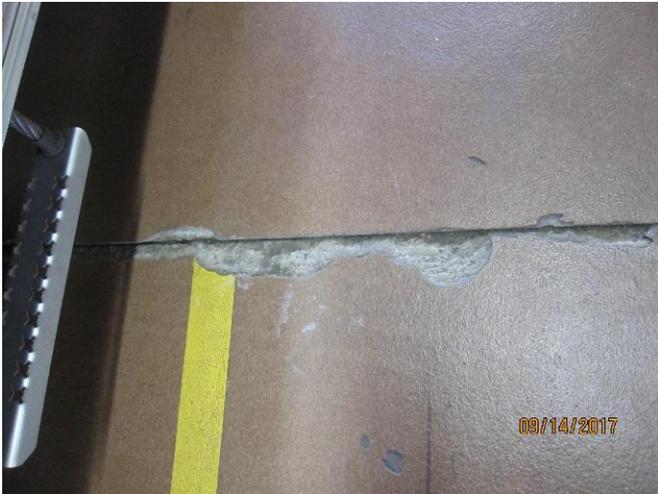
- i. The engine/apparatus room is in fair condition with the exception of a few cracks within the epoxy flooring system and a few areas where the concrete slab has spalled.

VISIBLE CRACK IN CONCRETE FLOOR

D. <u>Interior</u>	
i. Repair the cracks within the epoxy flooring system	\$8,500
ii. Patch the spalled concrete slab areas	\$3,500
iii. Remove the wall fabric finish and install gypsum wallboard on the exterior walls of the 2 nd floor meeting room	\$5,500

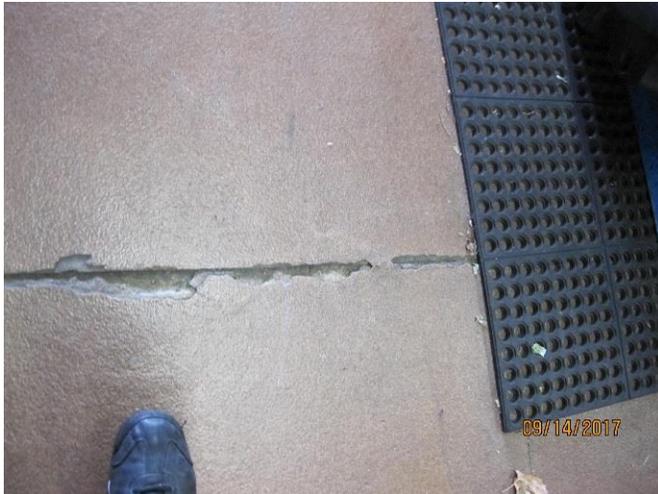
VISIBLE CRACK IN CONCRETE FLOOR

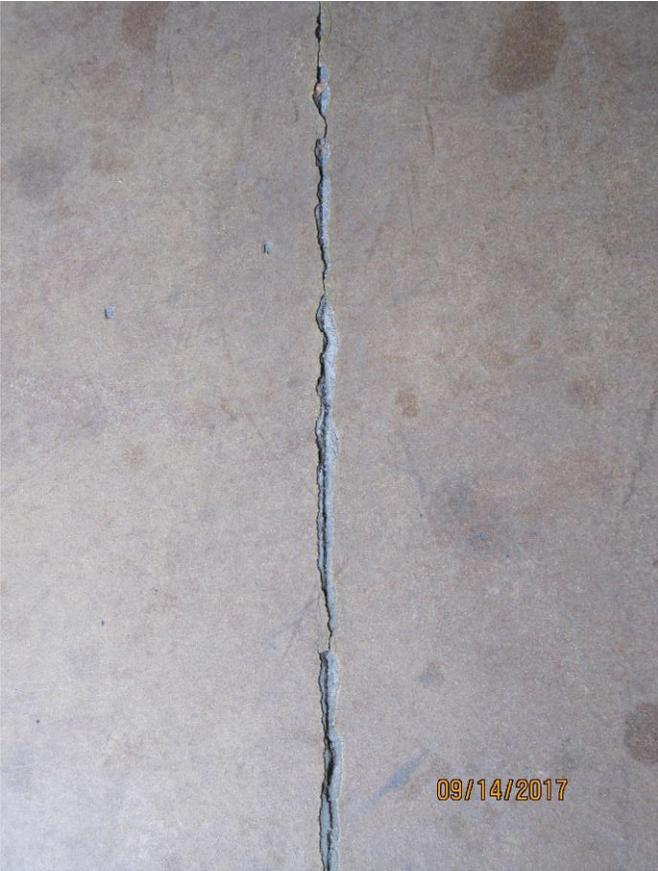
VISIBLE CRACK IN THE CONCRETE FLOOR

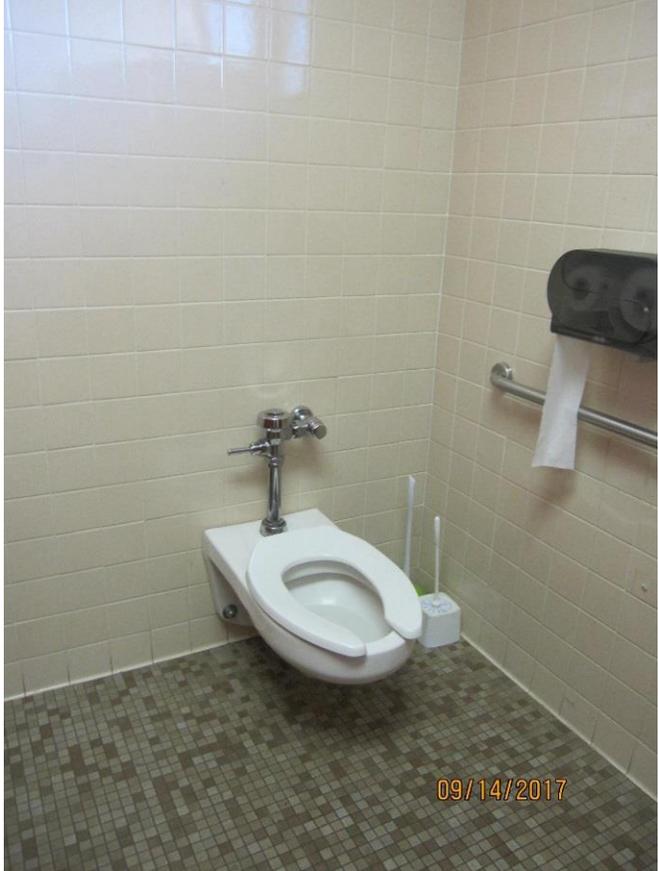
- v. The day room is used as their recreational room.
- vi. There are barrier free mens and womens bathrooms, showers and locker rooms located on the first floor. The mens bathroom is missing one grab bar behind the water closet. There are non barrier free mens and womens bathrooms on the second floor.

ADA STALL DOES NOT COMPLY WITH CURRENT CODE

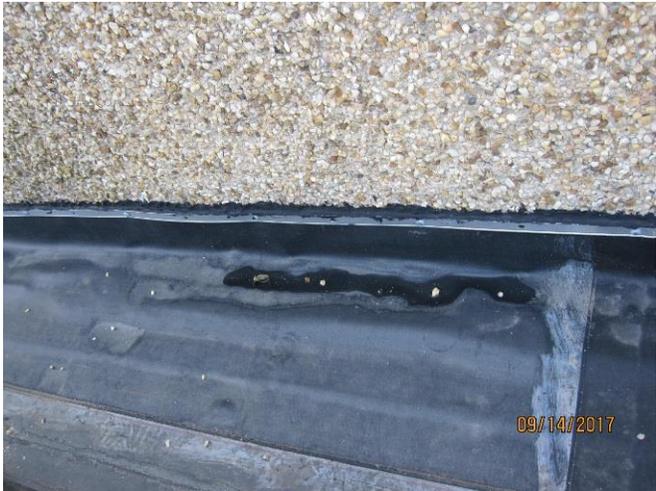
SIGNS OF WATER AND BLISTERS

C. <u>Roofs</u>	
i. Replace the single ply roofing system with a built-up roofing system	\$550,000
ii. Replace the metal copings	\$30,000
iii. Replace the skylights	\$18,000

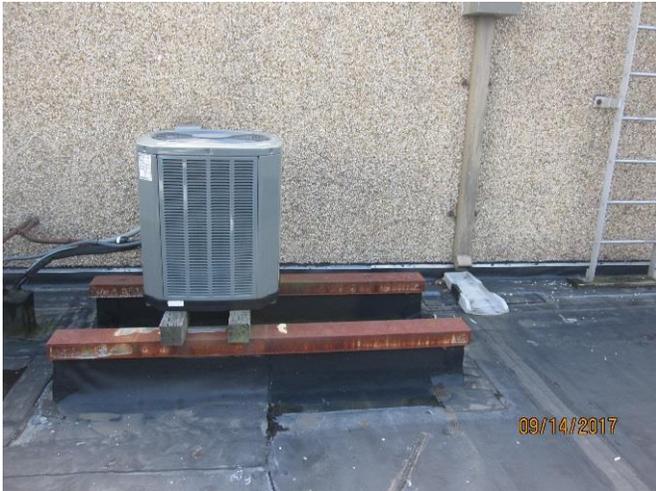
- iii. The skylights are original and in fair condition with no reported water infiltration leaks.
- iv. There is vegetation growing in one corner of the roof.
- v. The metal roof copings are in poor condition and the coping color has faded with age. The exposed coping fasteners are rusting. The sealant in the transverse joints of the parapet wall aluminum copings is alligating and oxidizing causing them to split open and fail.
- vi. We were informed during the field visit that the fire station has retained a roofing contractor to have the exposed aggregate panels located on the second floor wall adjacent to the lower roof removed and replaced with full height single ply roofing base flashing in an effort to stop water infiltration at this location.

RUSTED MECHANICAL CURBS COPING

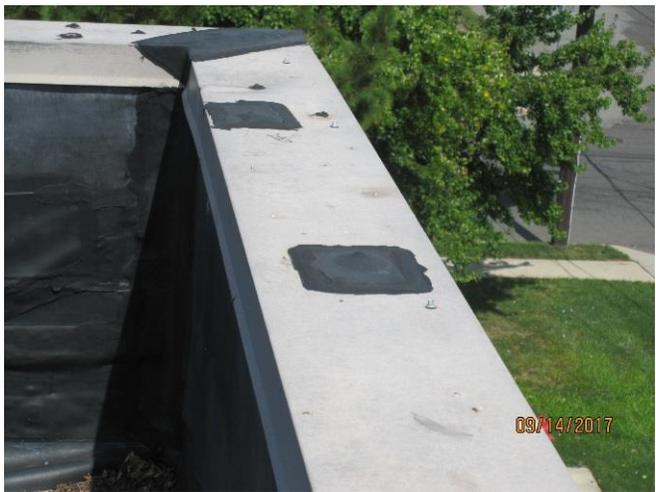
SIGNS OF PREVIOUS REPAIRS TO THE PARAPET COPING

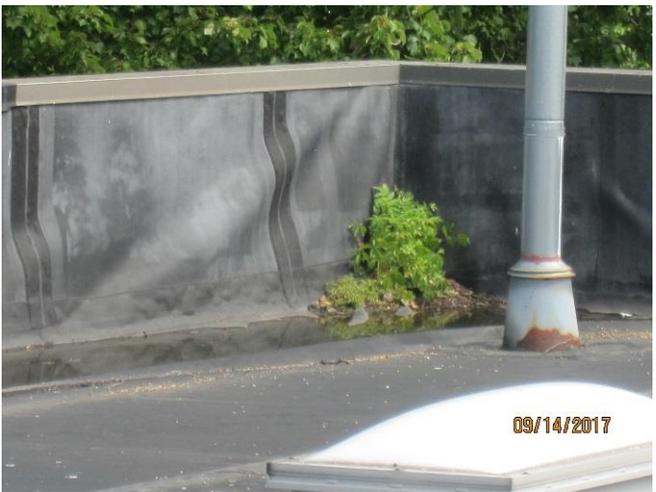
PRESENCE OF VEGETATION GROWTH ON THE ROOF INDICATES BAD DRAINAGE

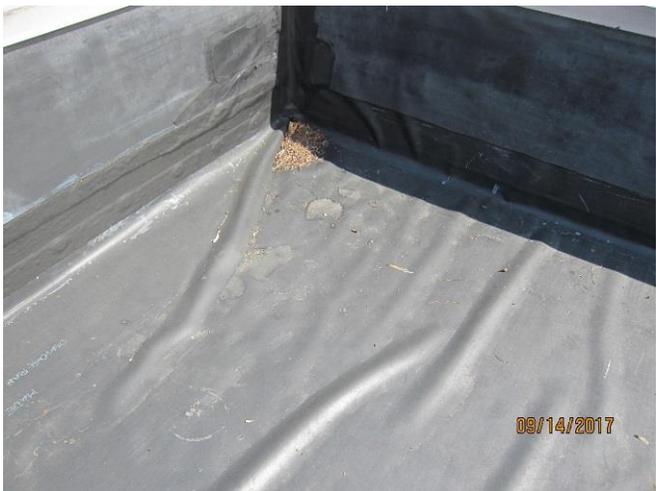
SIGNS OF BUBBLING UNDER THE MEMBRANE

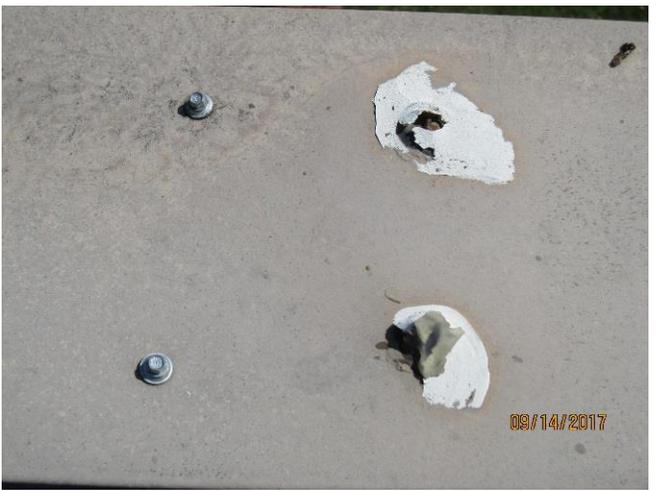
SIGNS OF PREVIOUS EFFORT TO SEAL THE ANCHORS' PENETRATION

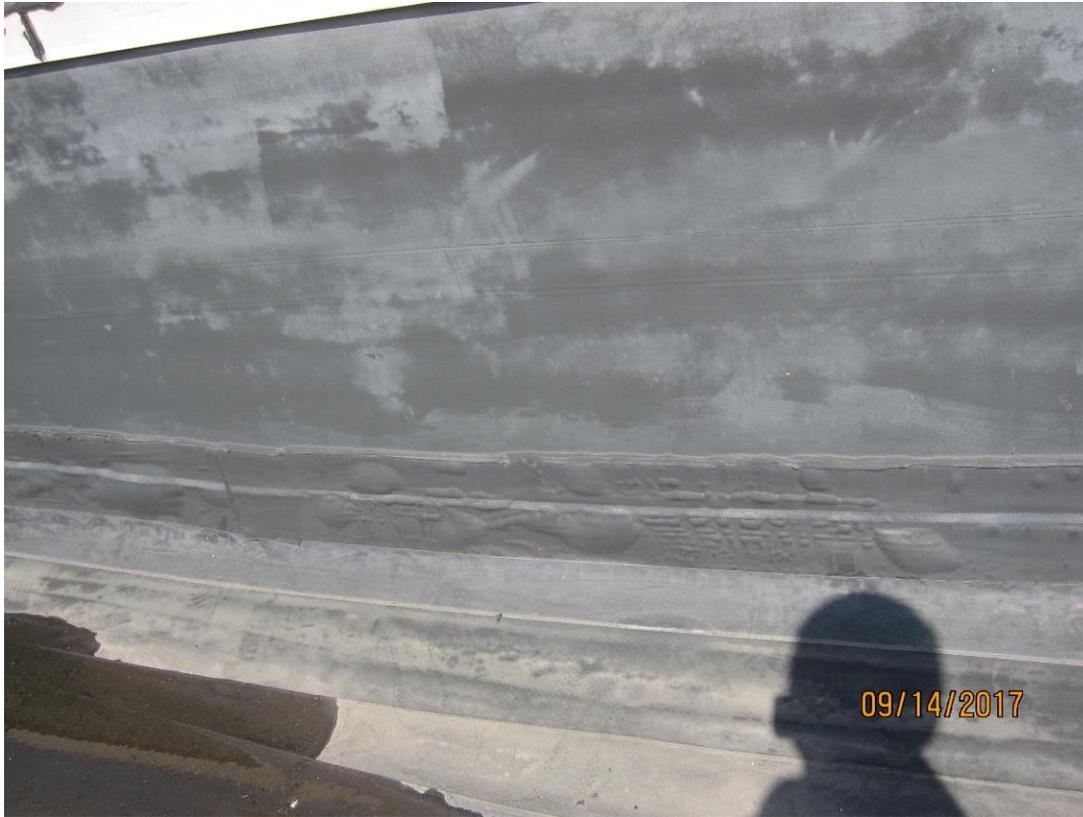
SIGNS OF BLISTERS IN THE BASE FLASHING

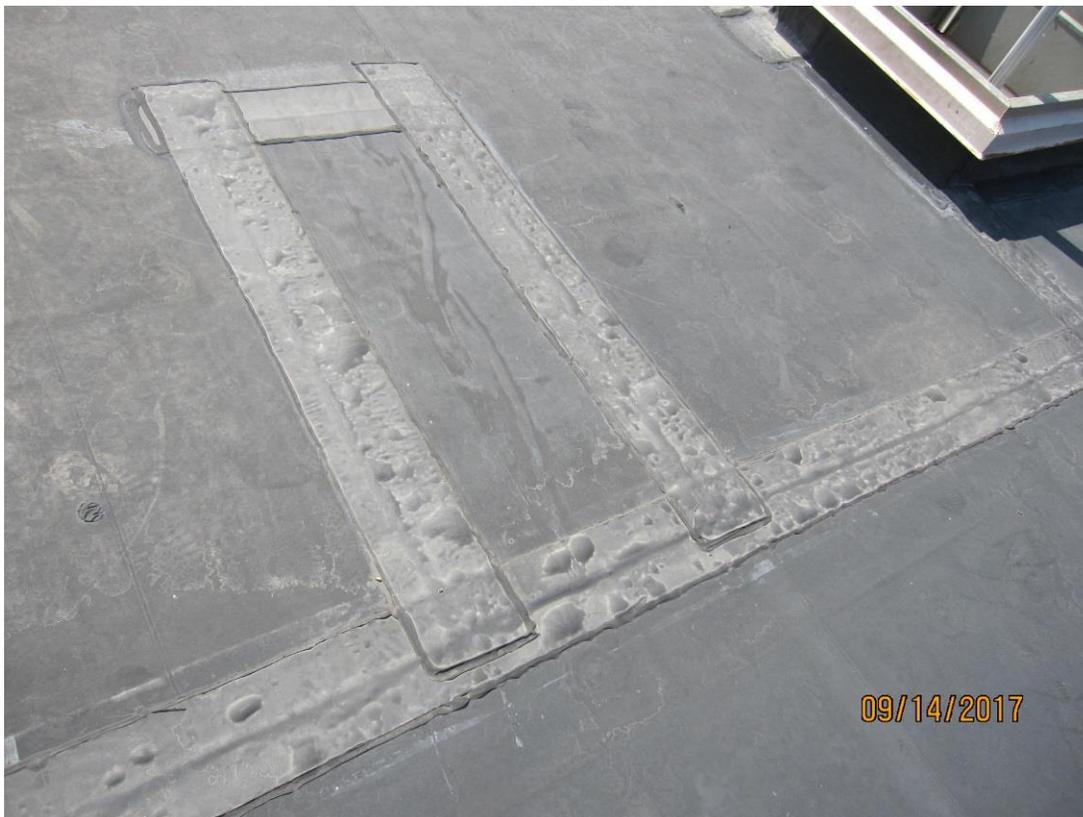
SIGNS OF BLISTERS AT THE SEAMS
