Hamilton Township Fire Dist. 4  
Fire Engine #14  
1085 East State Street, Hamilton, NJ 08609

## Feasibility Study

December 7, 2017

## **Fire Station # 14, Hamilton District 4 – Audit**

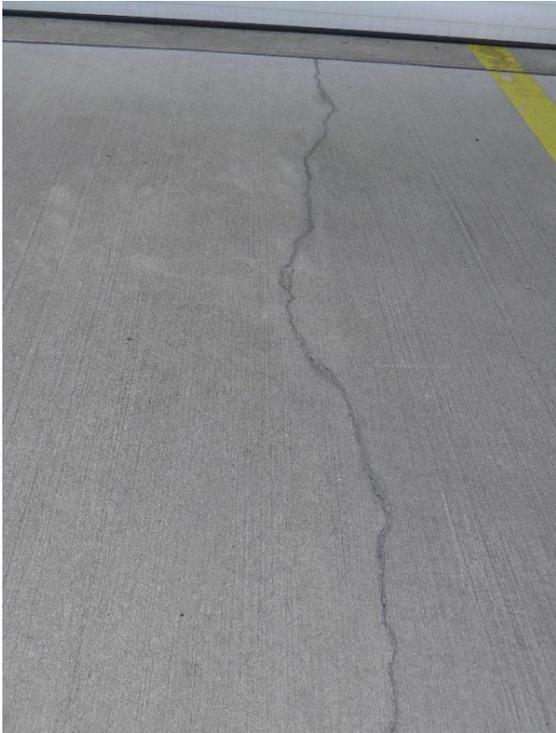
- A. The concrete apron at the (3) truck bay entrance is in good condition. However the concrete curb located between the apron and street is in poor condition containing many spalls and cracks.
- B. The concrete apron at the fourth currently unused truck entrance bay is in fair condition with one crack. The concrete curb located between the apron and street is in poor condition containing many spalls and cracks.
- C. The asphalt parking lot has a few cracks but is in fair condition.
- D. There are designated parking lot barrier free parking spaces.
- E. The station has barrier free entrances.
- F. There is a crack in concrete sidewalk along Hubert Ave.

VISIBLE CRACK IN THE SIDEWALK

<u>Work Item</u>	<u>Estimated Cost Opinion</u>
A. <u>Site</u>	
i. Replace concrete curb along street at the truck entrances	\$9,500
ii. Repair the cracks in the asphalt parking lot	\$10,500
iii. Repair crack in concrete sidewalk along Hubert Ave	\$1,200
B. <u>Facades</u>	
i. Repair the weather stripping on the overhead door.	\$500
ii. Reseal the perimeter of the aluminum fixed and awing

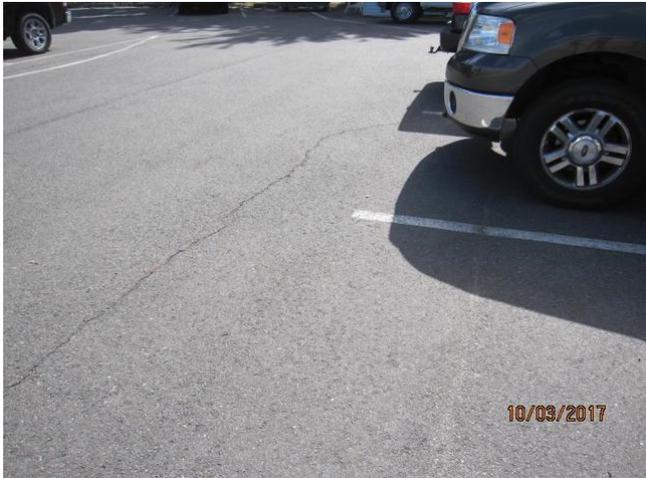
VISIBLE CRACKS IN THE PARKING LOT

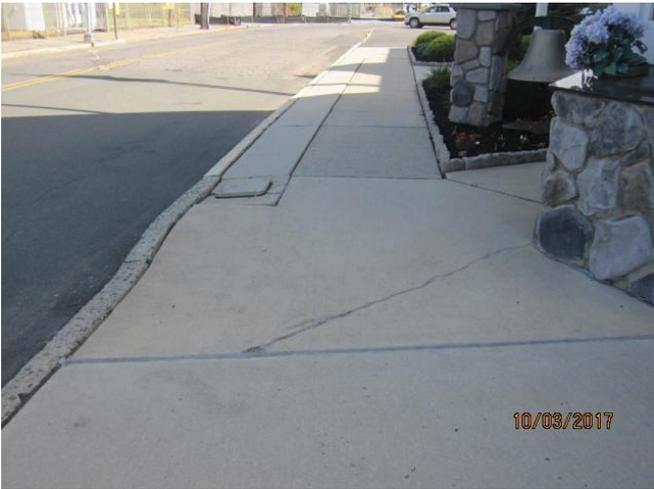
VISIBLE CRACK IN THE SIDEWALK

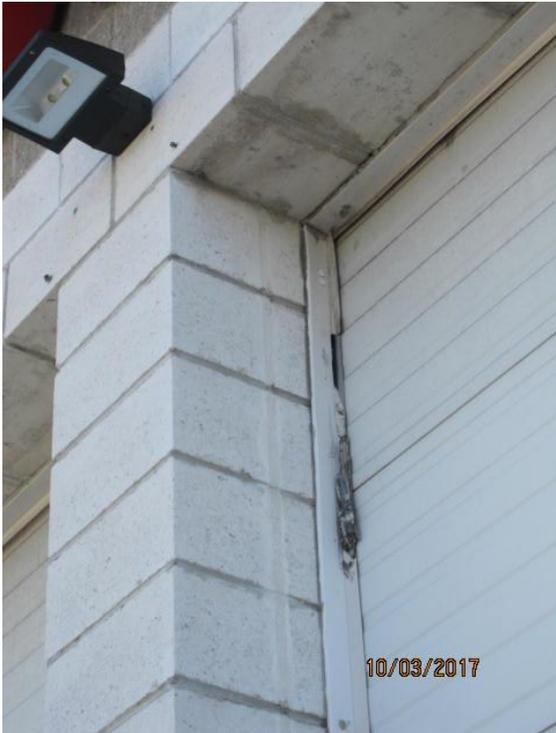
- ii. There is some damage to the weatherstripping on one of the overhead doors.
    - iii. The aluminum fixed and awing windows are original and in fair operational condition with no reported water infiltration leaks. The sealant around the perimeter of the windows is oxidizing causing it to split open and fail.

BROKEN GARAGE DOOR SEAL

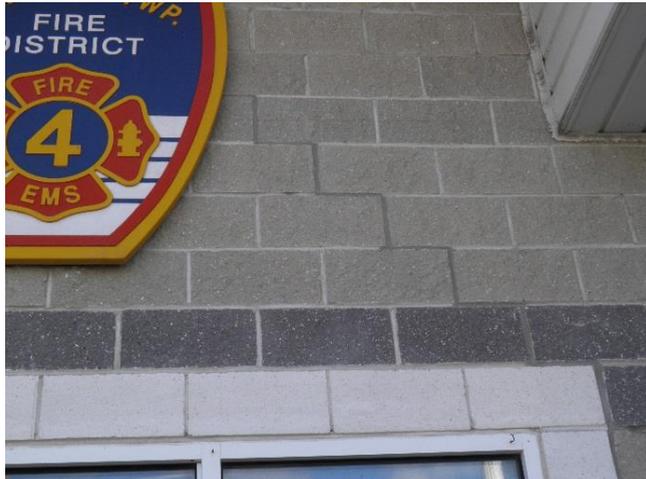
- ii. The hollow metal personnel door and frame are in poor condition with, rusting at the door sill and the bottom of the door frame.
  - iii. The building expansion joint is either missing or oxidizing causing it to split open and fail.
  - iv. The previous masonry patch in the ground face concrete masonry unit is starting to opening up around the edges.
  - v. There are no overhead truck bay doors on this facade.
4. West Elevation (E State Street)
- i. The hollow metal personnel door is in fair condition.
  - ii. There are no overhead truck bay doors on this facade.
  - iii. The sealant around the perimeter of the doors and windows is oxidizing causing it to split open and fail.
- B. Roofs
- i. The facility has a pitched standing seam metal roofing system with gutters and downspouts on the various roofs. These roofs are in good condition and there have been no reported roof leaks.

VISIBLE REPAIRS TO PREVIOUS MASONRY CRACKS

v. Reseal the building expansion joint	\$750
vi. Repair the previous patch in the ground face concrete masonry unit	\$500
C. <u>Roofs</u>	
<u>N/A</u>	
D. <u>Interior Accessibility of Station (*)</u>

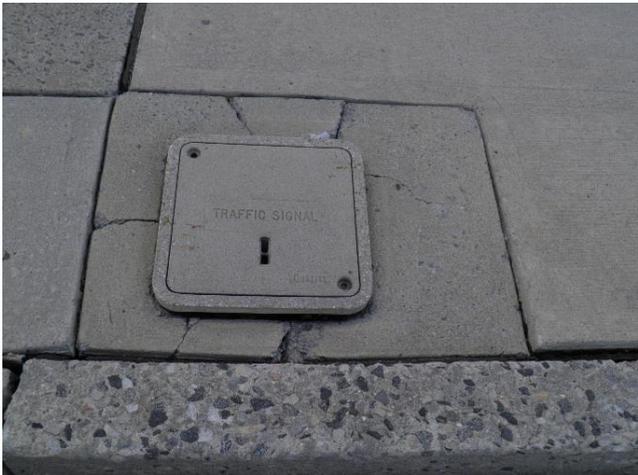
VISIBLE CRACK IN THE SIDEWALK

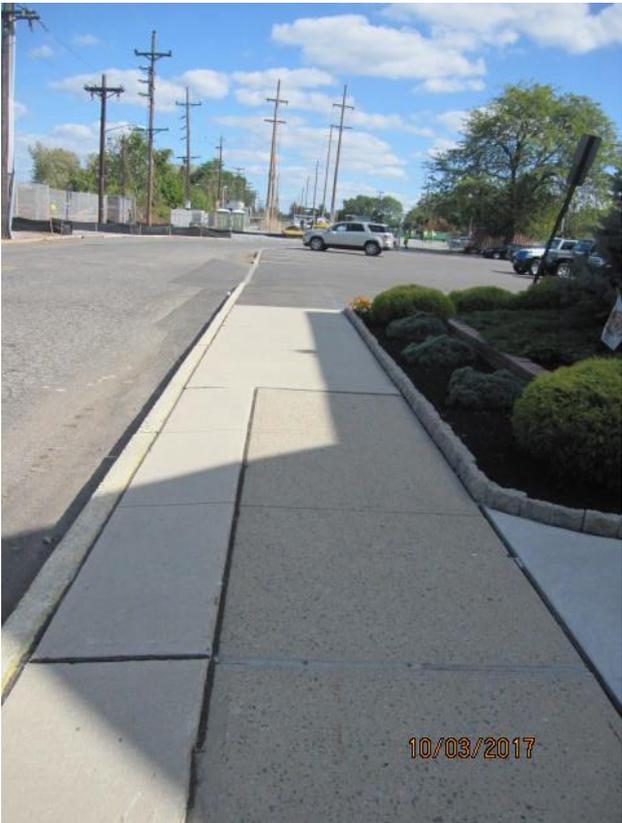
UNEVEN SIDEWALK

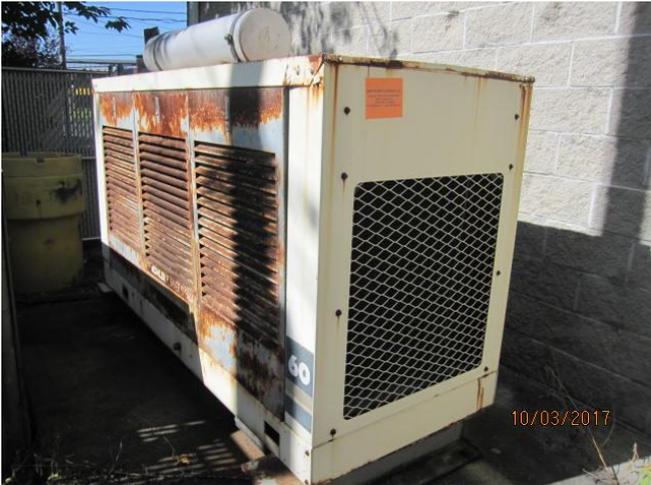
- A. A 60 KW natural gas generator serves the emergency loads. Manufacturer is Kohler. Model No. Power System 60. The generator is at least 20 years old and appears to be in poor condition. There seems to be significant rusting on the generator housing.

GENERATOR ENCLOSURE SHOWING SIGNS OF RUST

i. Replace the generator	\$50,000
ii. Relocate the existing electrical equipment & incoming service to a dedicated electrical room	\$20,000
Sub-Total Cost Opinion	\$243,550
Contingency (20%)	\$48,710
<b>Total Cost Opinion</b>	<b>\$292,260</b>
<b>Say</b>	<b>\$293,000</b>

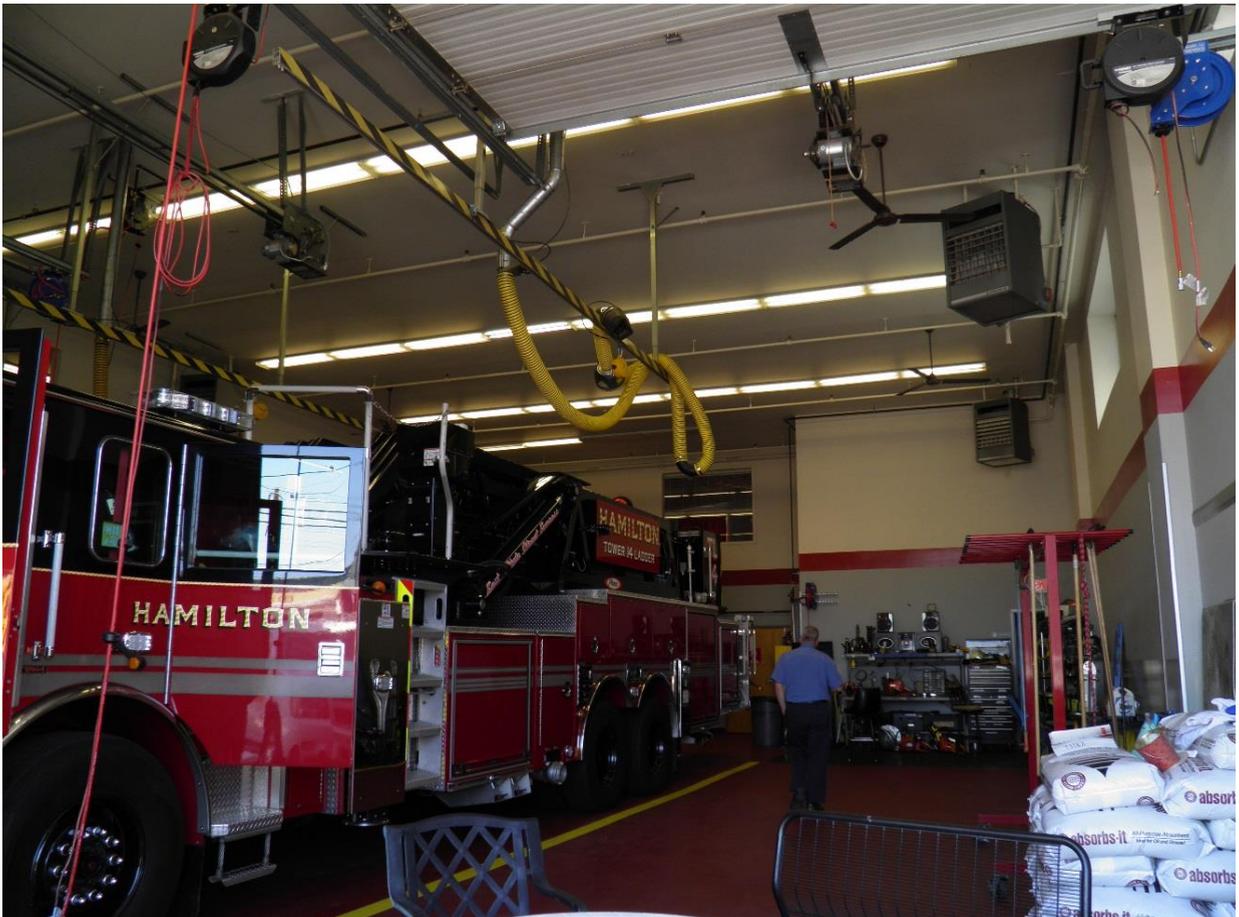
## INTERIOR CONDITIONS

INTERIORS ARE IN GOOD CONDITION.  
NO MAJOR ISSUES OBSERVED

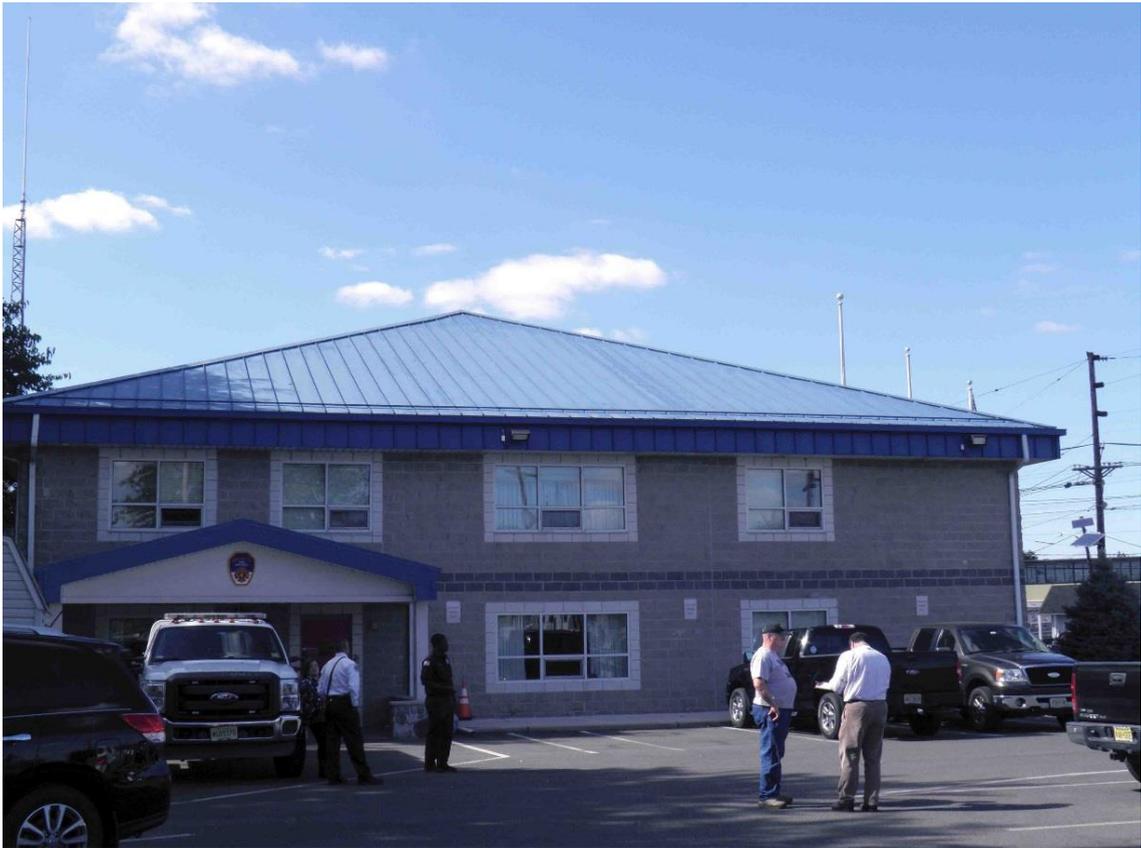
STANDING SEAM METAL ROOF IS IN GOOD CONDITION.  
NO MAJOR ISSUES OBSERVED
