De Cou Hose Company
Fire Engine #15
61 Ruskin Avenue, Hamilton, NJ 08610

Feasibility Study

Fire Station # 15, Decou District 5 – Audit

Fire Station Audits

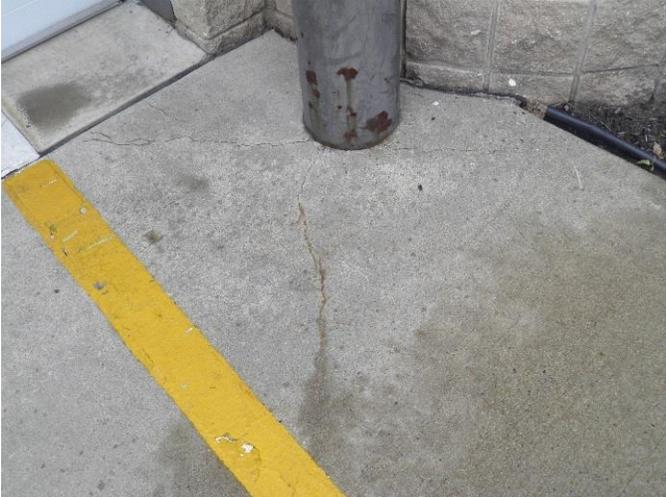
VISIBLE CRACK IN CONCRETE SIDEWALK

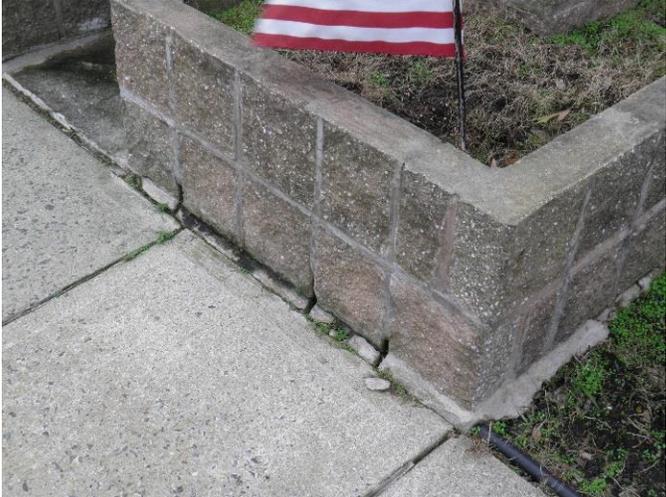
VISIBLE DAMAGE TO THE BRICK PLANTER

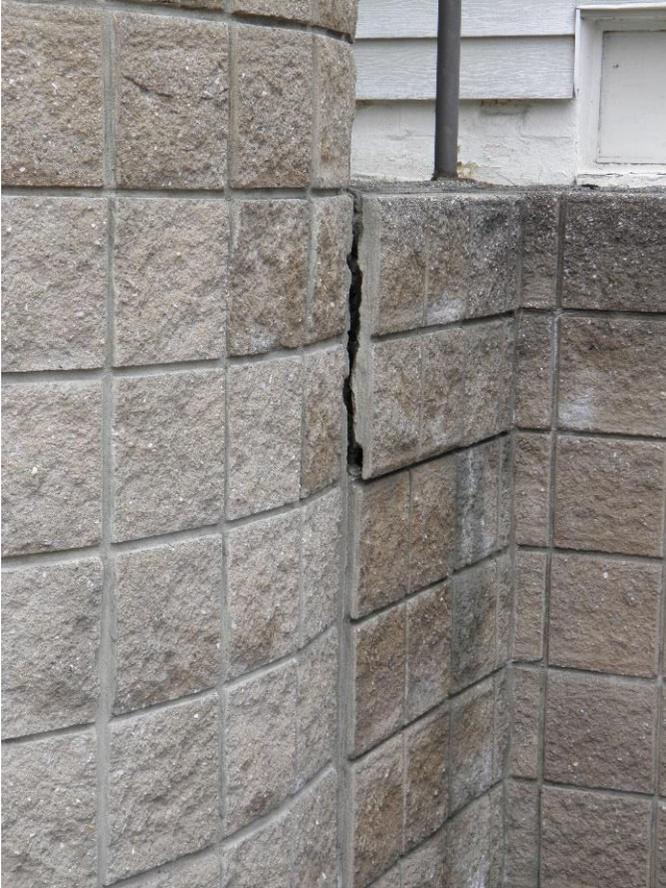
SEVERE CRACKS TO THE MASONRY WALL

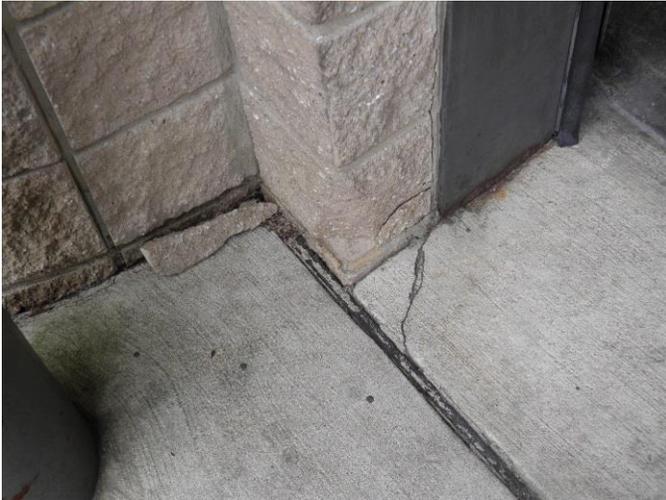
SPALLING IN MASONRY BLOCKS AND CRACKS IN CONCRETE SIDEWALK

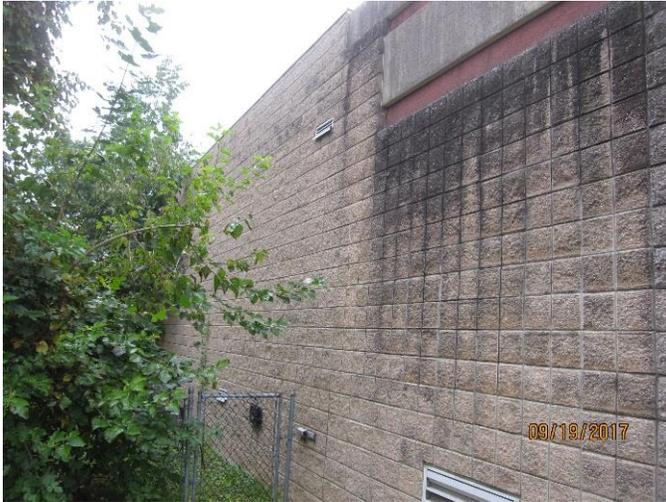
VISIBLE DIRT FROM WATER RUNOFF

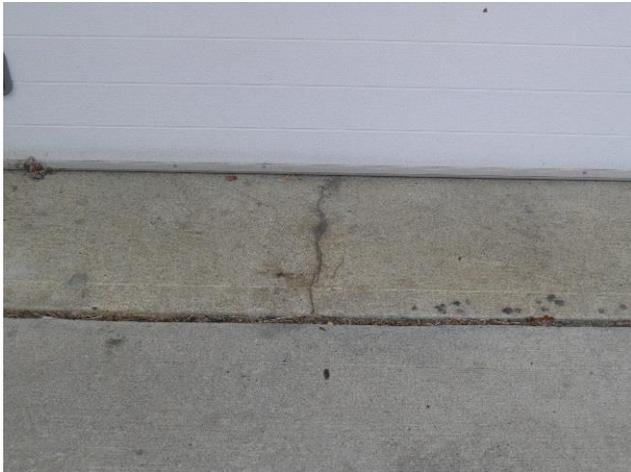
CRACK IN CONCRETE SIDEWALK

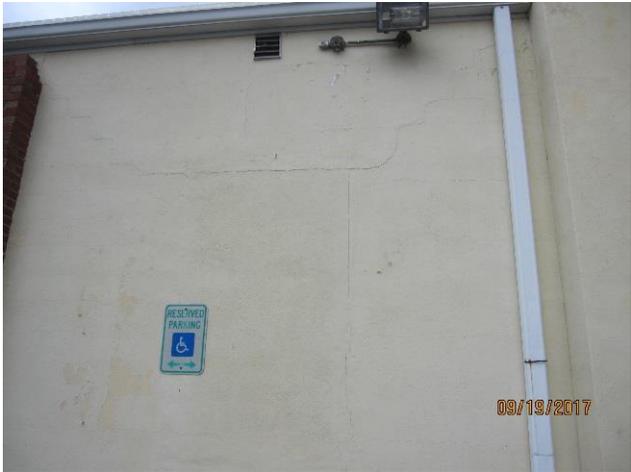
VISIBLE CRACK ON THE WALL

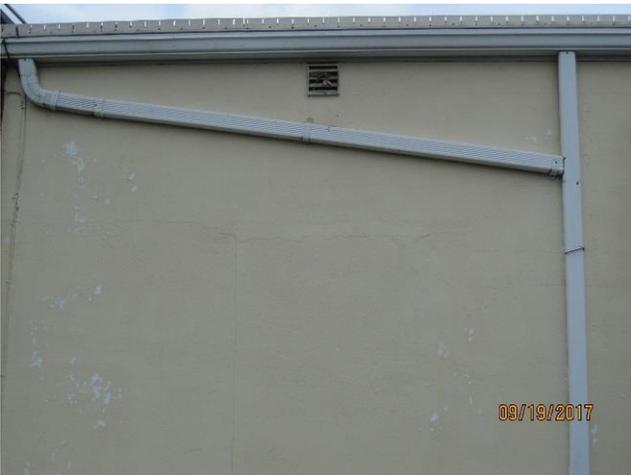
VISIBLE CRACKS AND PAINT PEELING ON THE WALL

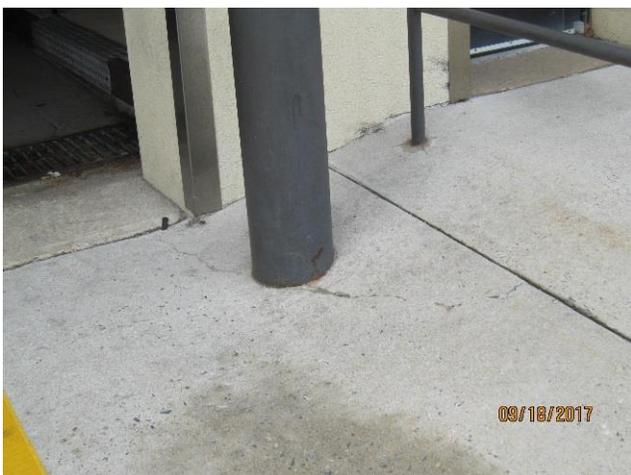
VISIBLE CRACK IN THE CONCRETE PAVERS

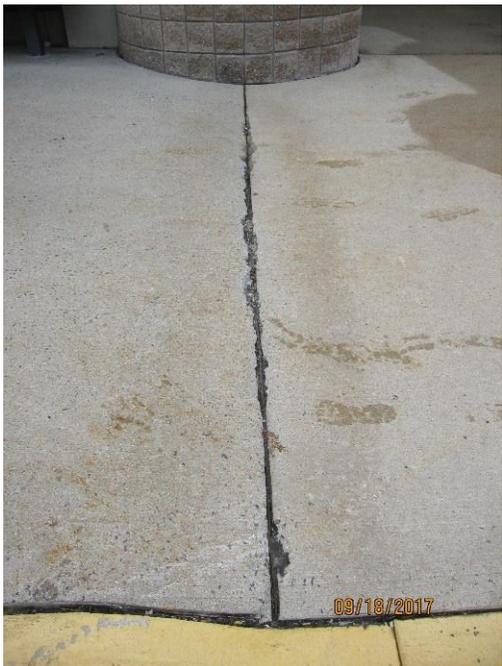
VISIBLE EROSION AT CONCRETE JOINT

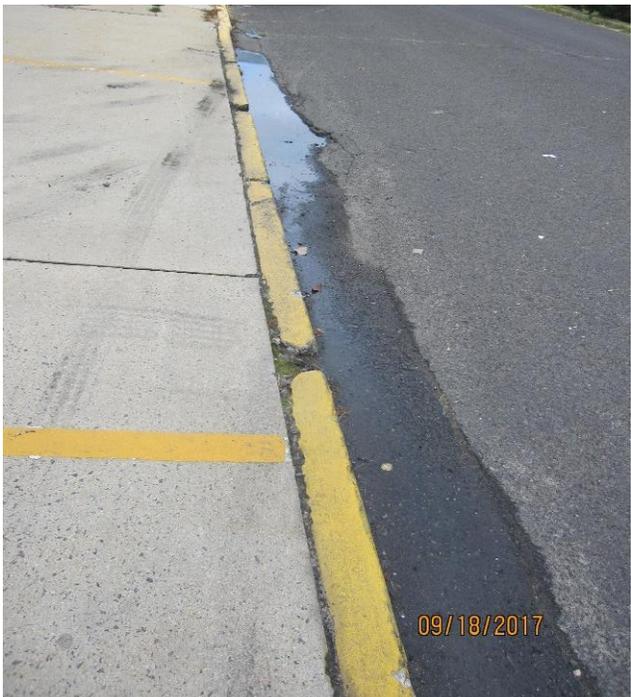
VISIBLE DAMAGE TO CURB

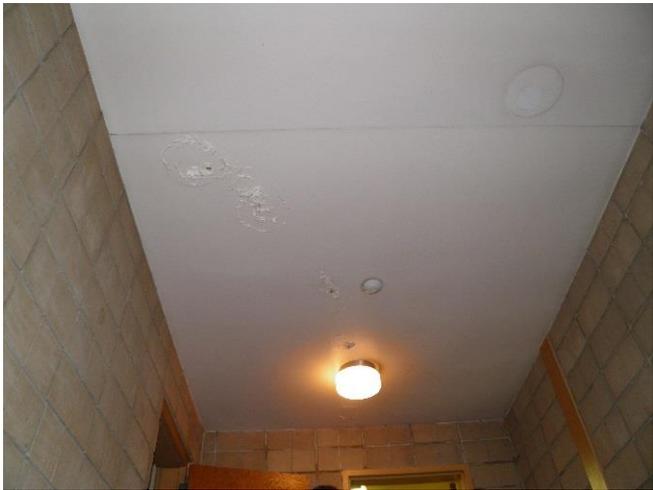
PAINT PEELING AT GYPSUM BOARD CEILING

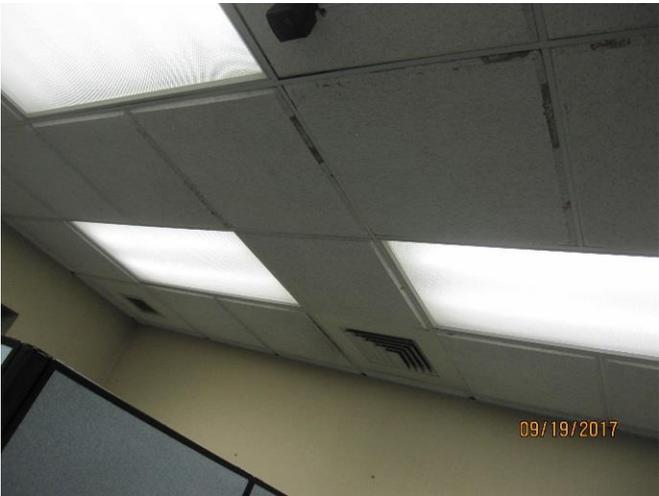
VISIBLE DAMAGE TO THE CEILING TILES

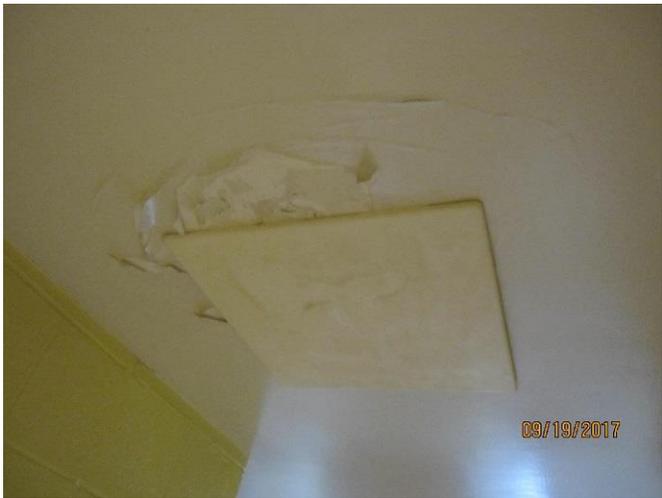
PAINT PEELING AT GYPSUM BOARD CEILING

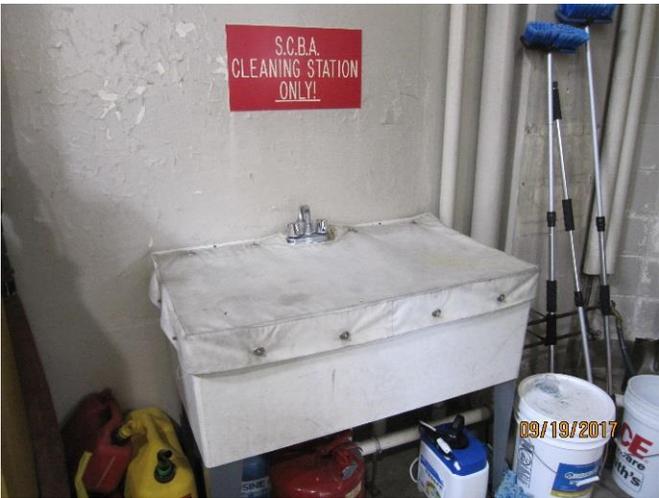
PAINT PEELING AT WALL

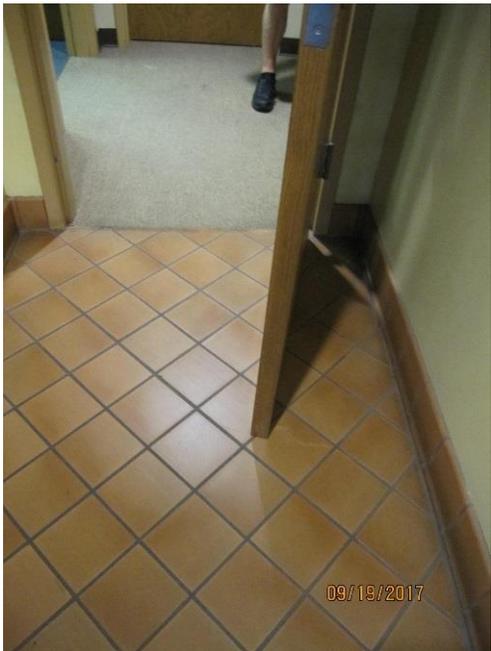
3. The wood door leading into the vestibule outside of the fire commissioners office is non-barrier free and the bottom of this door is scraping the floor tile.
4. The offices are in fair condition.
5. There is only one non-barrier free bathroom in area 1 on the second floor.
6. Area 2
7. The lounge room is in fair condition.
8. The offices are in fair condition.
9. There is only one non-barrier free bathroom in area 2 on the second floor.

DOOR IN CONTACT WITH TILE FLOOR

v. Replace acoustical ceiling tiles	\$600
vi. Repair the wall tile on the column in the auxiliary engine room	\$500
vii. Repair the fabric wall covering in the dormitory room	\$500
viii. Repair the floor tile and bottom of the door to eliminate the scraping at the floor tile	\$1,000
<u>E. Interior Accessibility of Station (*)</u>

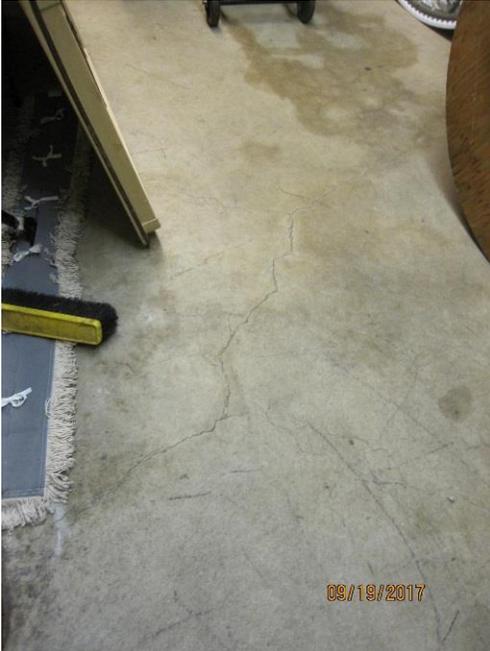
VISIBLE CRACKS IN CONCRETE FLOOR

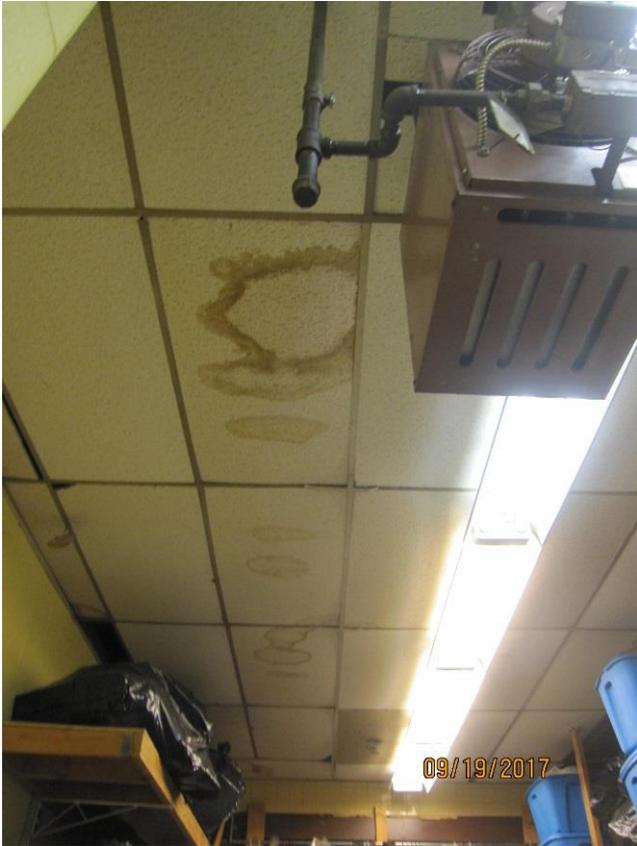
SIGNS OF WATER LEAKEAGE IN CEILING

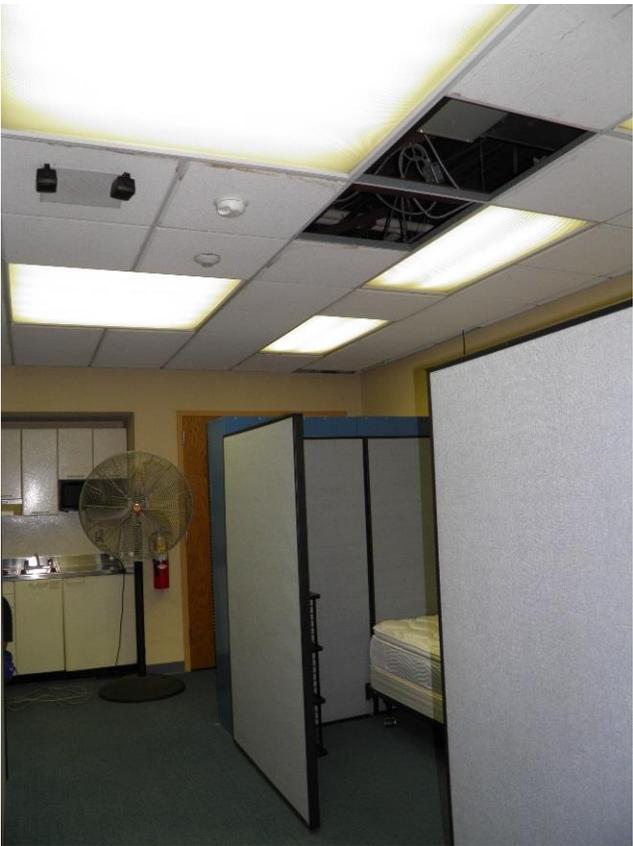
DAMAGED AND MISSING CEILING TILES

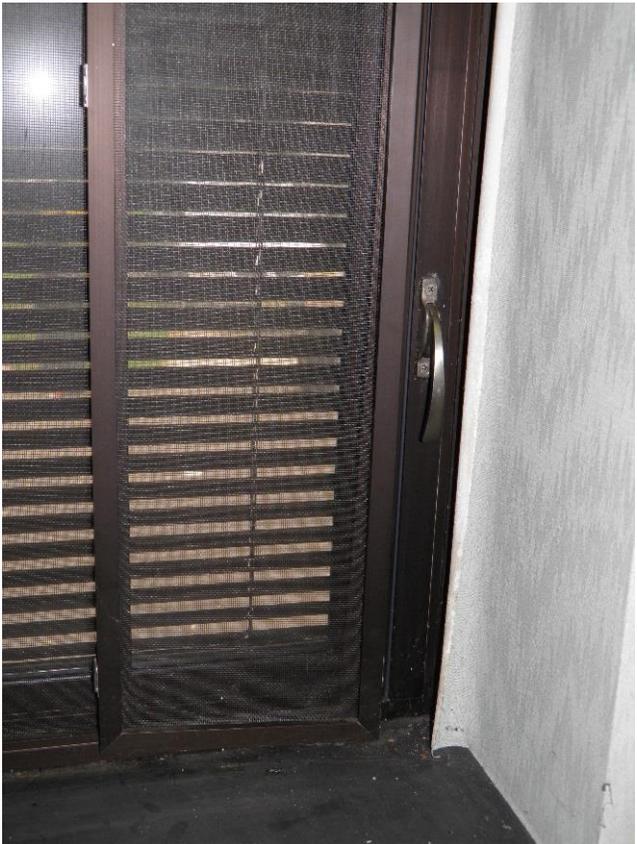
3. The Board of Fire Commissioners Office is in good condition.
2. The dormitory has 4 beds, and currently there is no separate dormitory room for the female staff. A kitchenette unit is located within the dormitory and is currently not used. The room was originally a board room and was converted into a dormitory. The fabric wall covering is peeling off at the window jamb and head within the dormitory room.

WALLPAPER PEELING OFF AT WINDOW JAMB

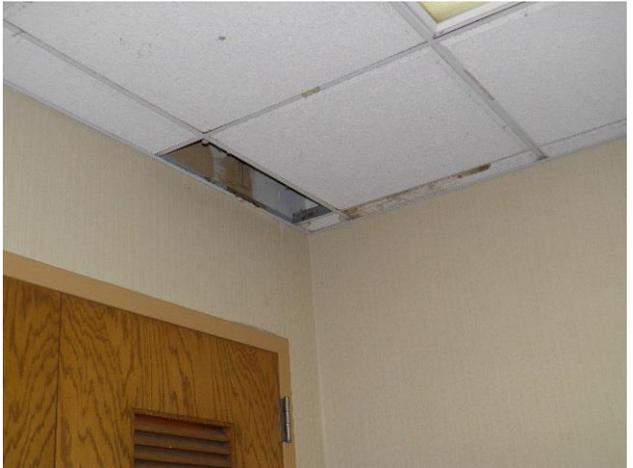
DAMAGED AND MISSING CEILING TILES

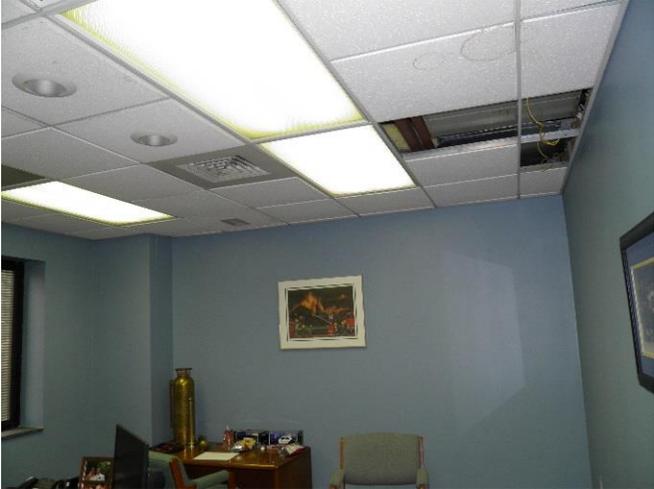
MISSING CEILING TILE

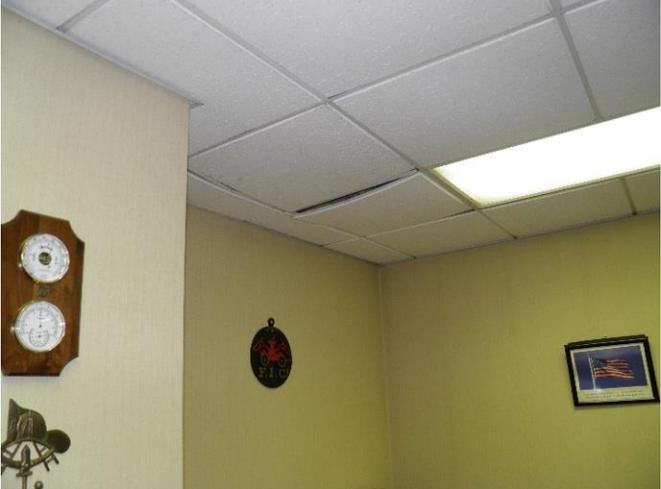
VISIBLE DAMAGE TO THE CEILING

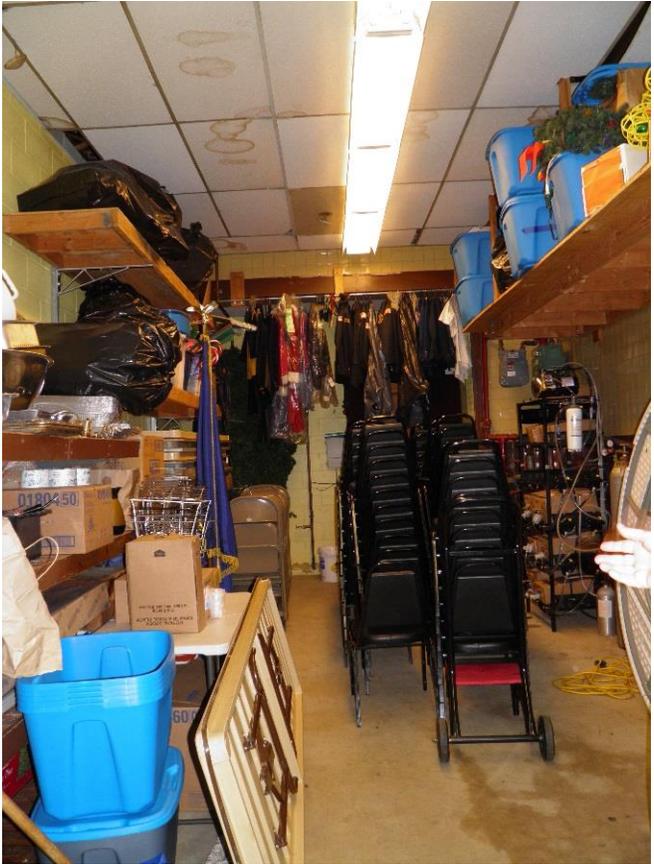
SIGNS OF WATER LEAKEAGE IN CEILING

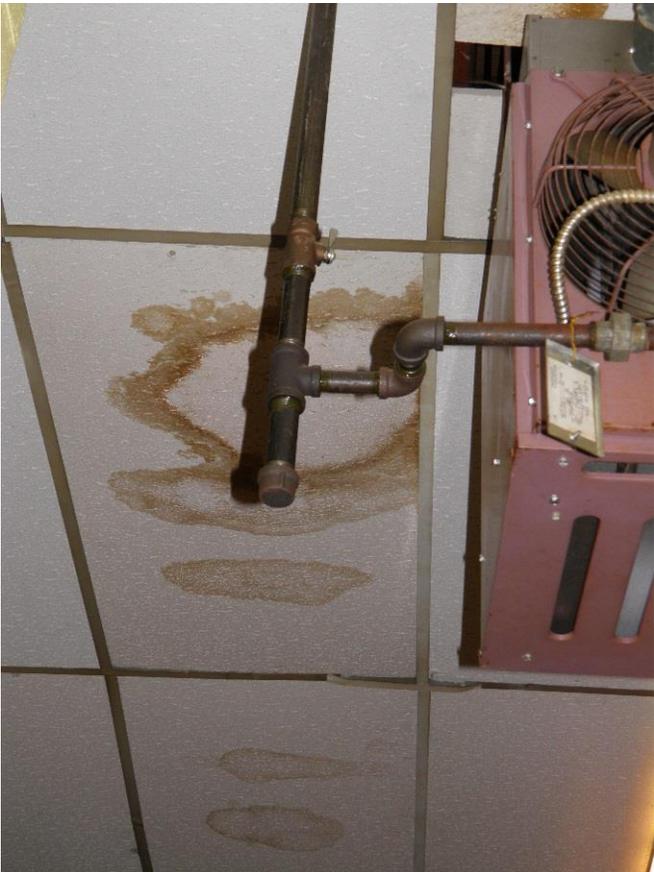
SIGNS OF WATER LEAKEAGE IN CEILING

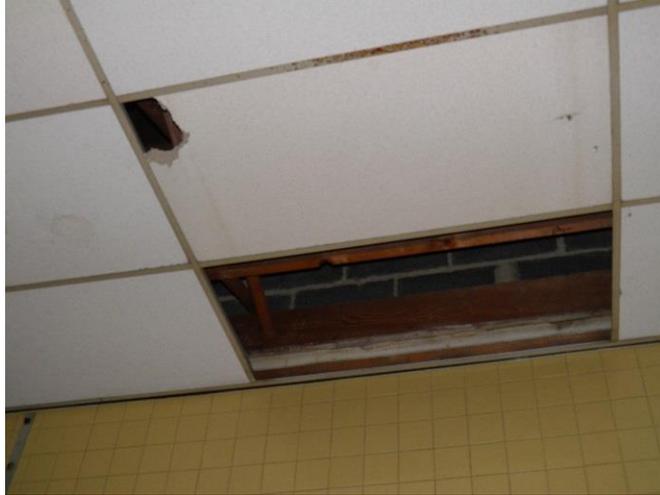
MISSING AND DAMAGED CEILING TILES

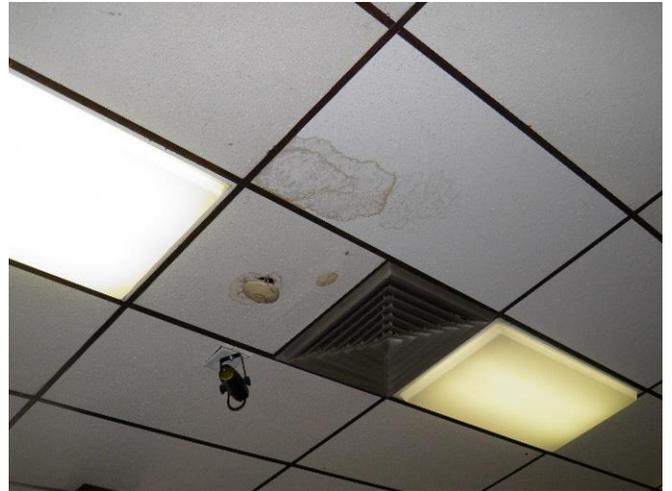
SIGNS OF WATER DAMAGE IN CEILING TILES

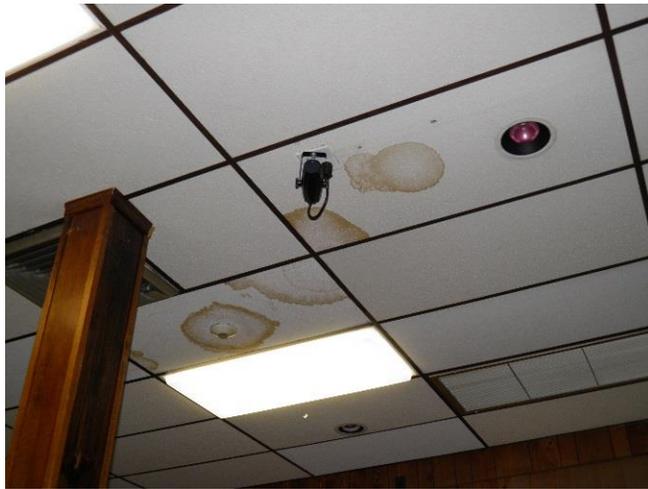
SIGNS OF WATER DAMAGE IN CEILING TILES

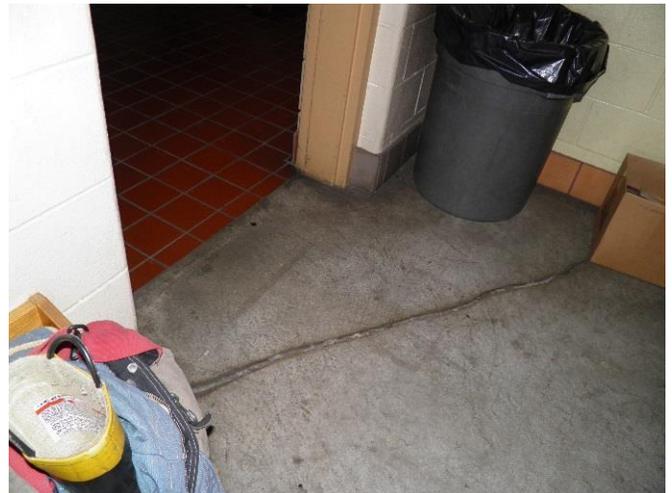
VISIBLE CRACK IN CONCRETE FLOOR

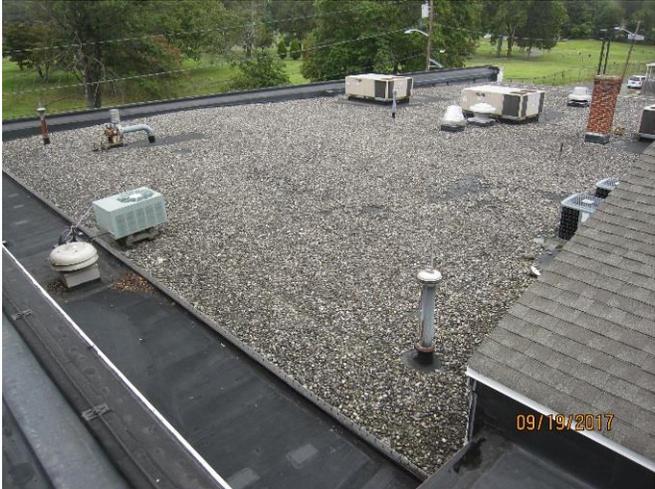
AREAS OF MISSING GRAVEL BALLAST

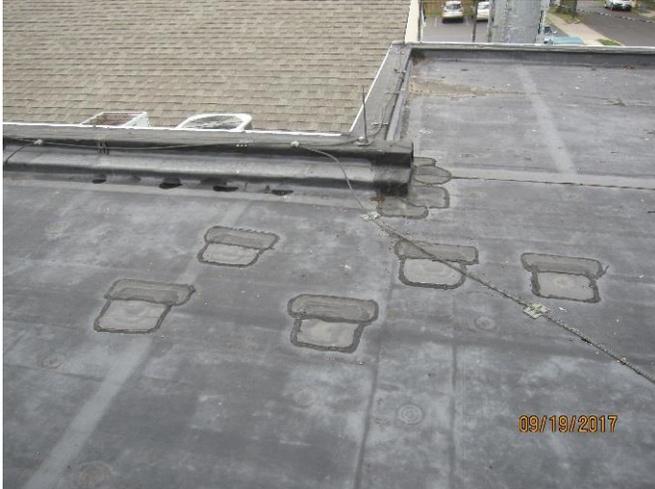
VISIBLE ROOF PATCHES

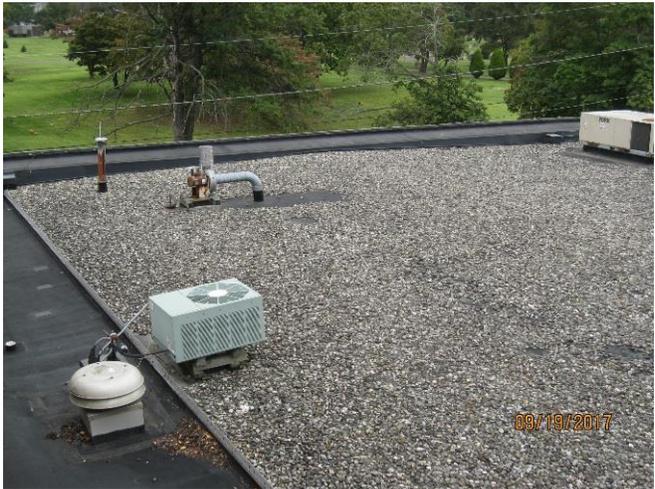
AREAS OF MISSING GRAVEL BALLAST

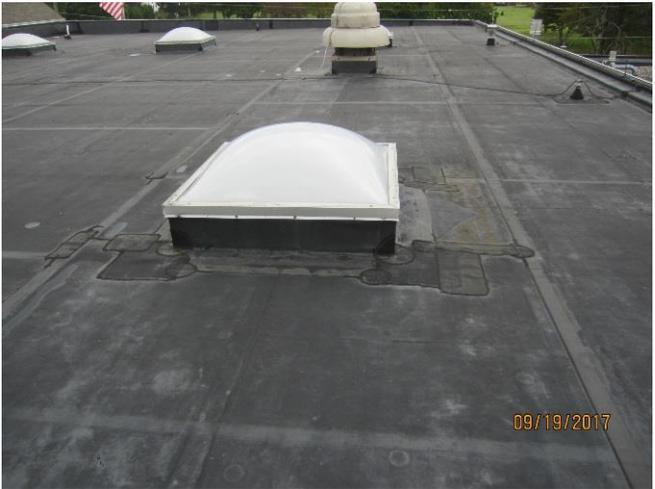
VISIBLE ROOF PATCHES

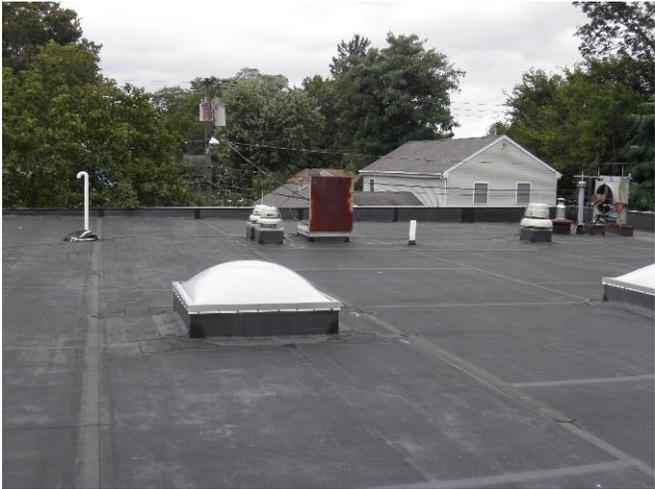
RUSTED ROOF ACCESS DOOR
