White Horse Fire Company
Fire Engine #16
19 Locust Avenue, Hamilton, NJ 08610

Feasibility Study

December 7, 2017

Fire Station # 16, White Horse District 6 – Audit

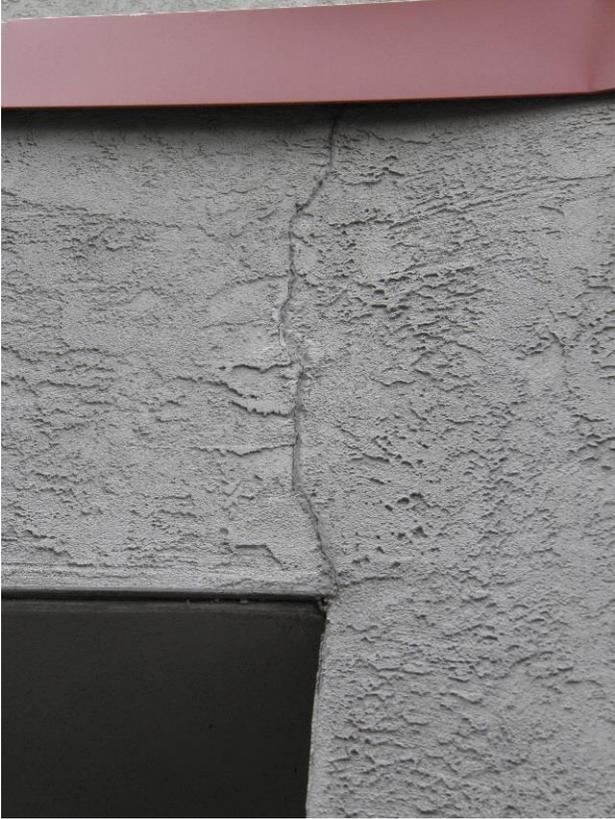
VISIBLE CRACK IN THE WALL

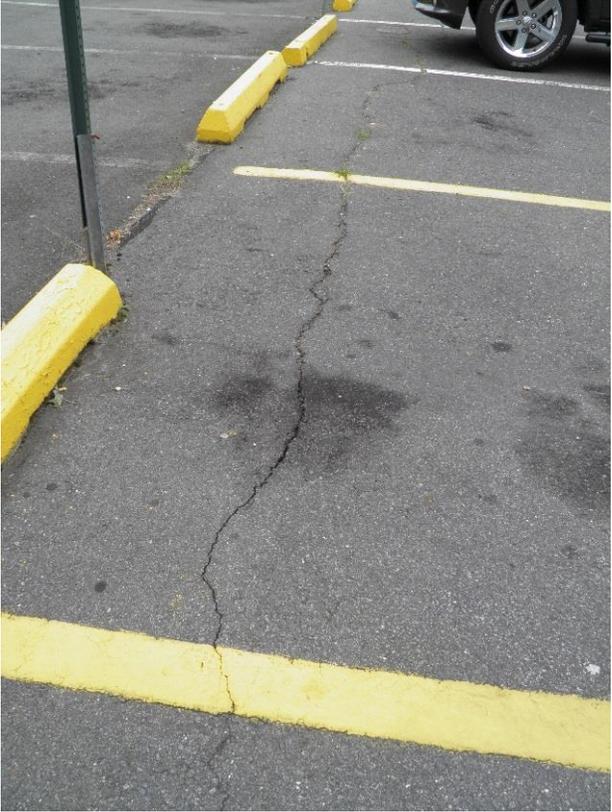
- F. The station parking lot and the parking lot adjacent to the banquet hall is in poor condition with many pot holes and cracks.
- G. There is a spall in the concrete curb/sidewalk located at the station parking lot.

VISIBLE CRACK IN THE PARKING LOT

v. Replace the station asphalt parking lot	\$260,000
vi. Repair the concrete curb/sidewalk at the station parking lot	\$1,200
B. <u>Facades</u>	
i. Repair the roof scupper box that has shifted slightly	\$750

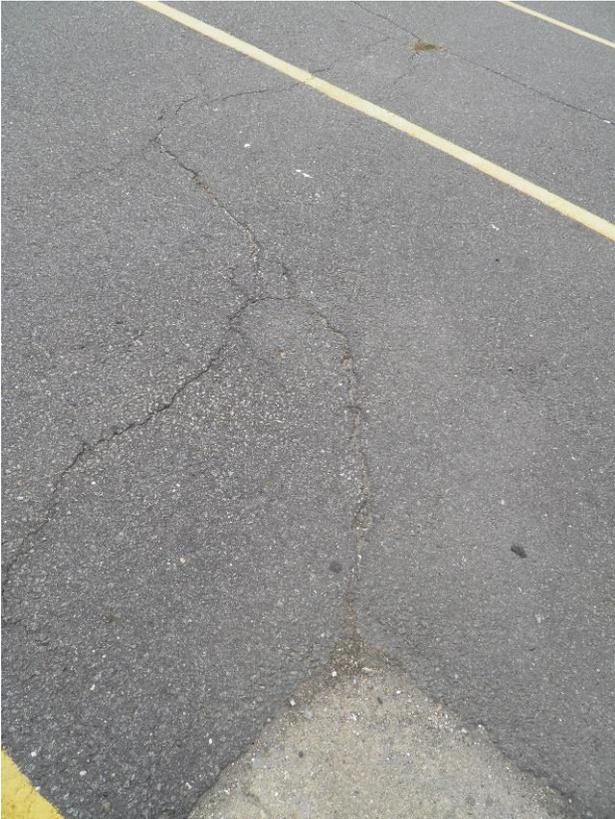
VISIBLE CRACKS IN THE PARKING LOT

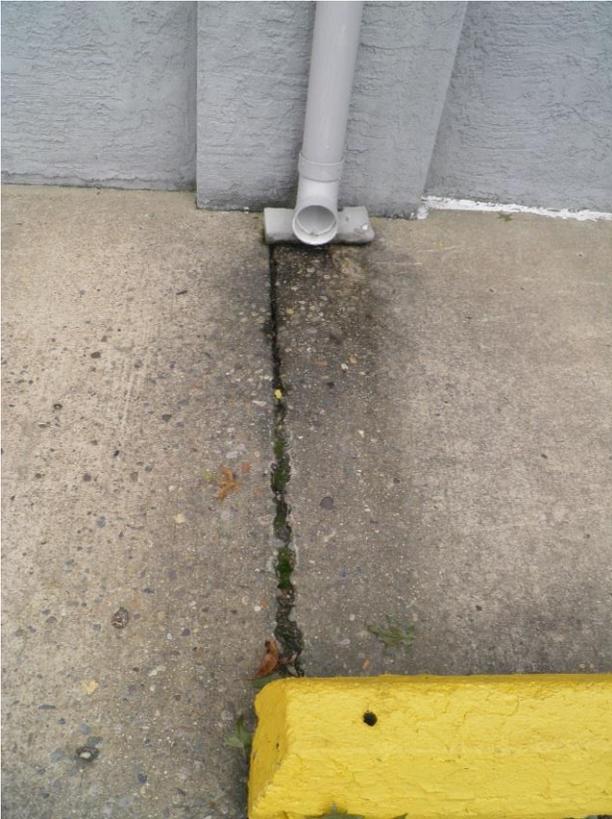
ERODED CONCRETE JOINT

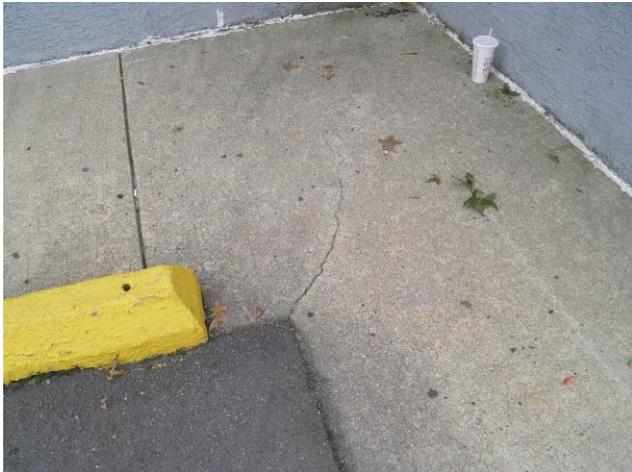
VISIBLE CRACK IN THE CONCRETE PAVERS

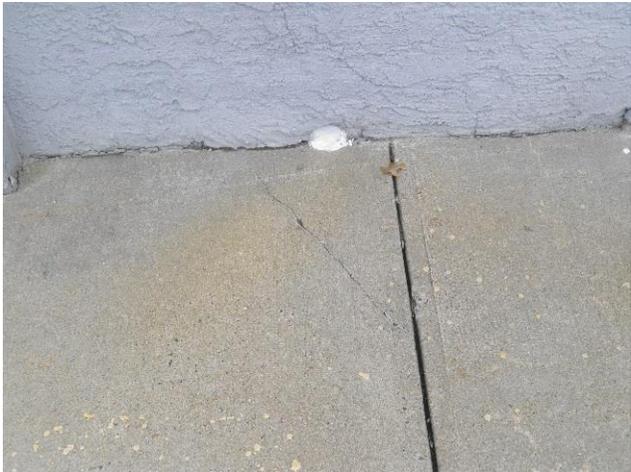
VISIBLE CRACK IN THE CONCRETE PAVERS

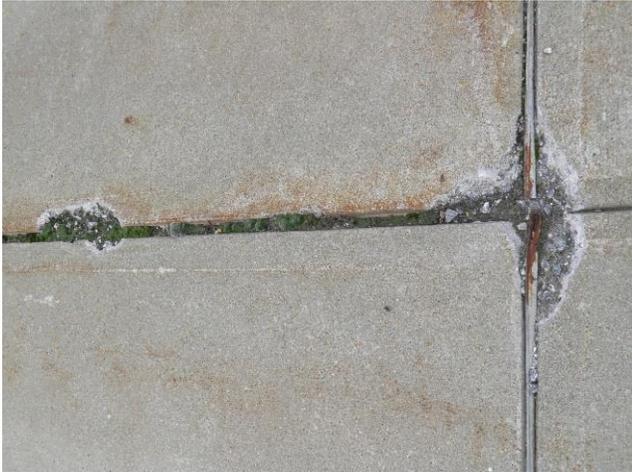
VISIBLE CRACK IN THE CONCRETE PAVERS

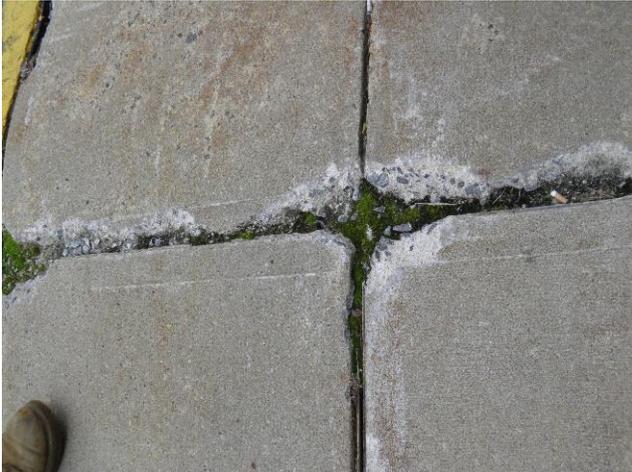
VISIBLE CRACK IN THE CONCRETE PAVERS

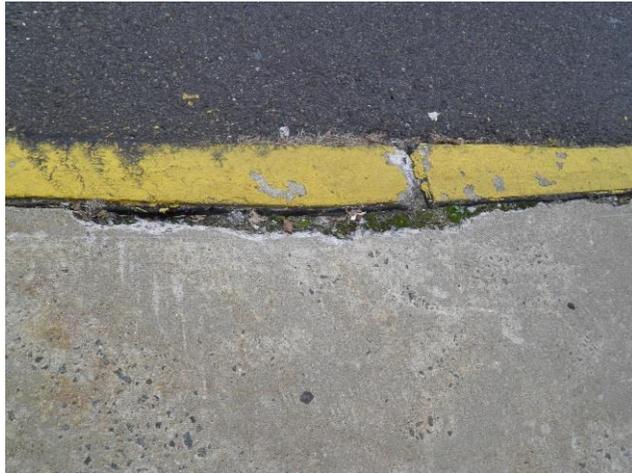
VISIBLE EROSION AT CONCRETE JOINT

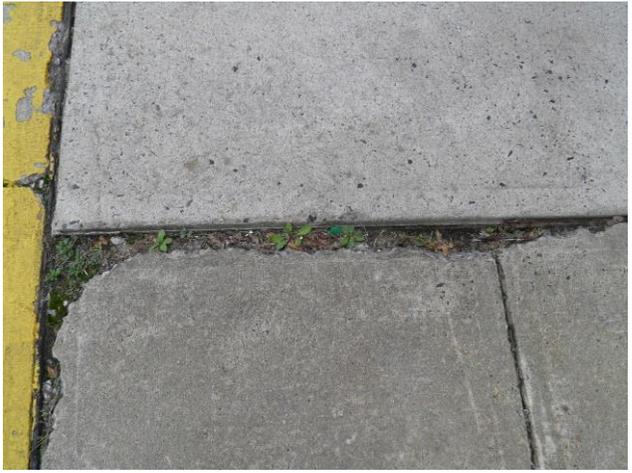
VISIBLE EROSION AT CONCRETE JOINT

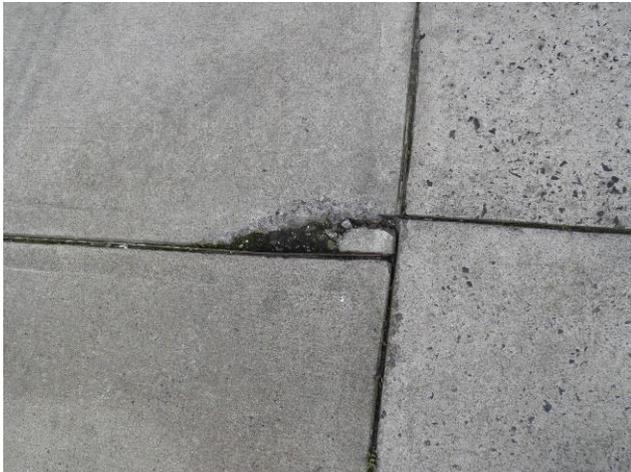
VISIBLE EROSION IN THE CONCRETE PAVERS

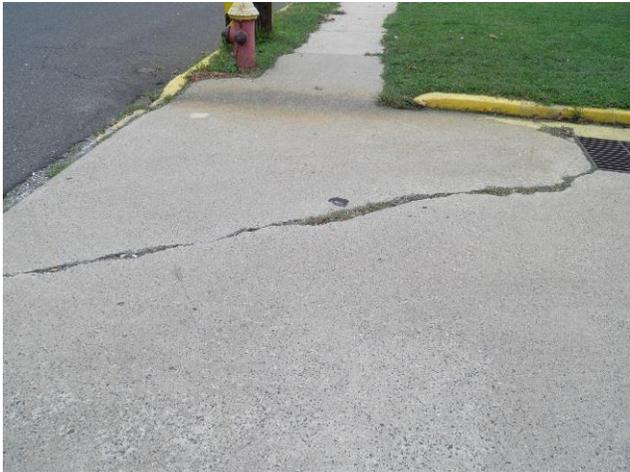
VISIBLE CRACK IN THE CONCRETE PAVERS

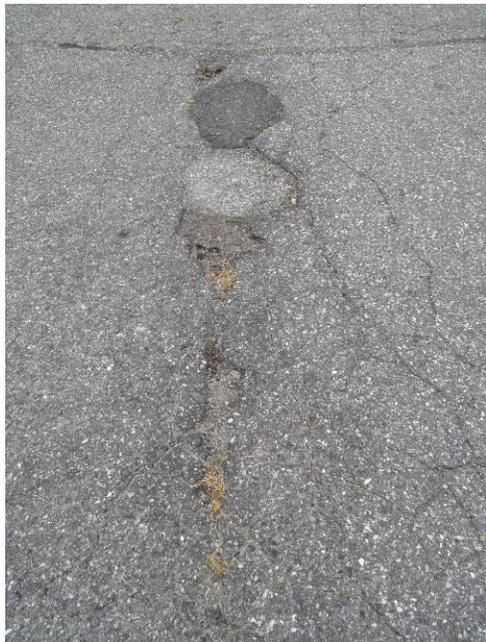
VISIBLE CRACKS IN THE DRIVEWAY

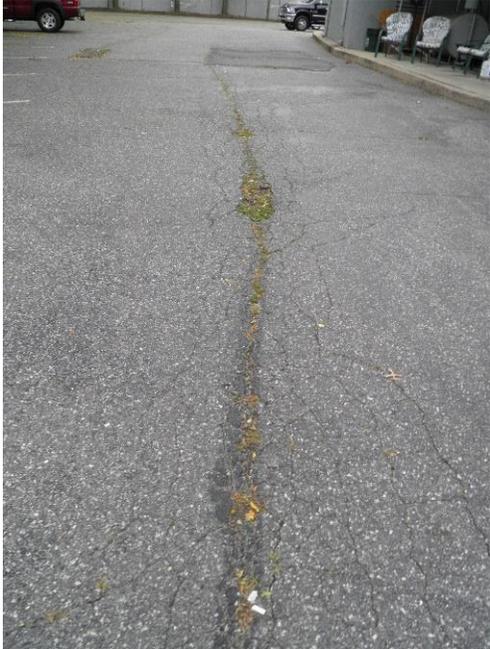
VISIBLE CRACK IN THE DRIVEWAY

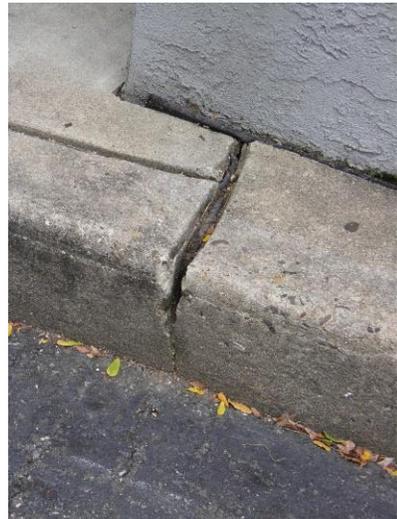
VISIBLE DAMAGE TO CURB

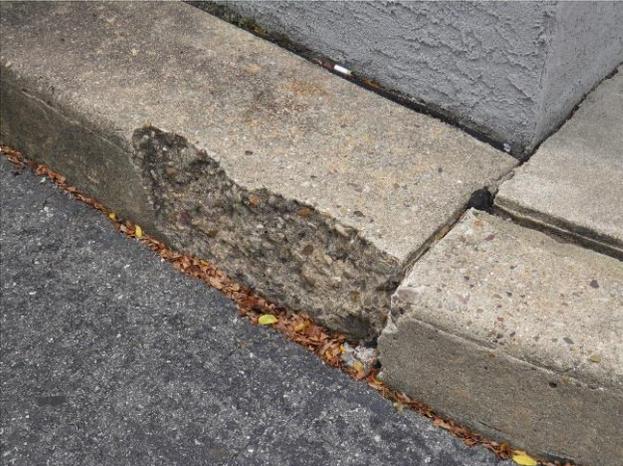
VISIBLE DAMAGE TO CURB

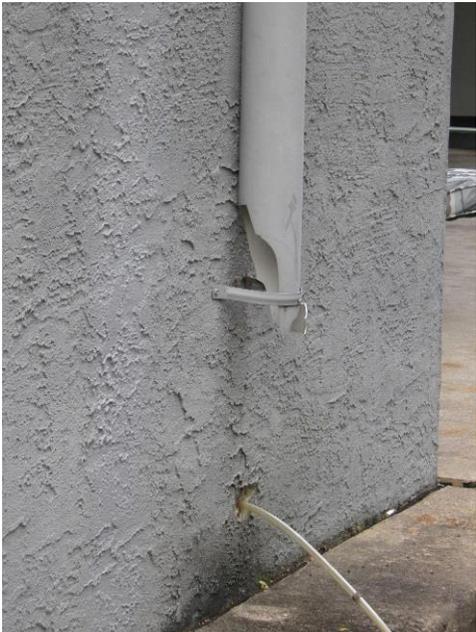
DAMAGED RAIN LEADER

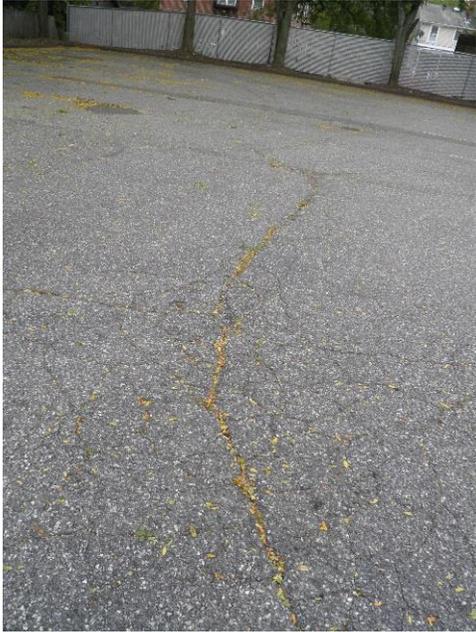
VISIBLE CRACK THE PARKING LOT

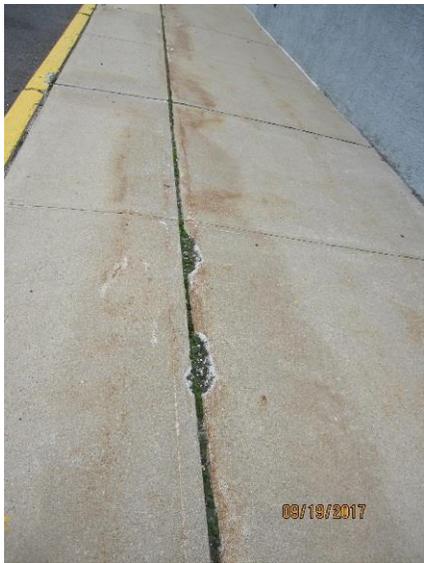
VISIBLE EROSION AT CONCRETE JOINT

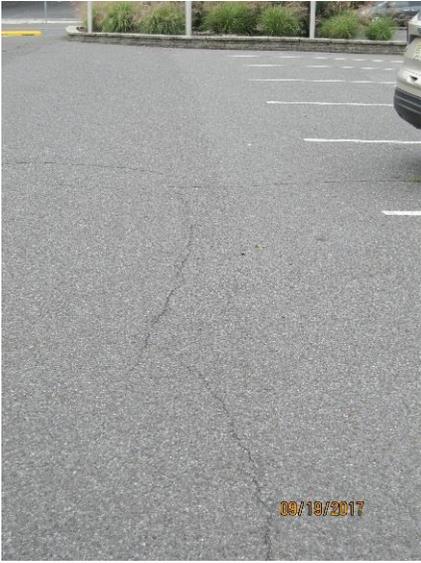
VISIBLE CRACK IN THE PARKING LOT

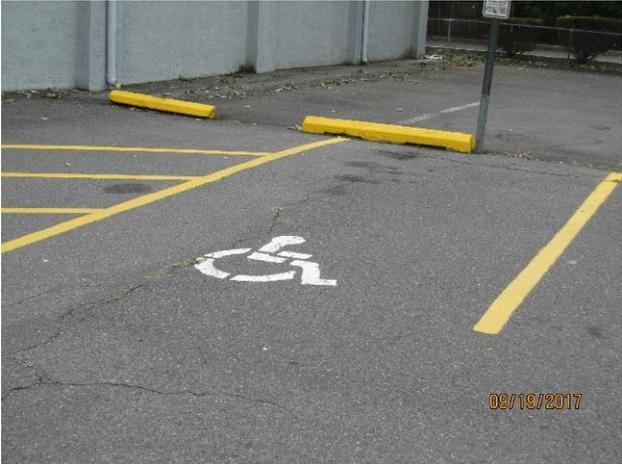
VISIBLE CRACK IN THE PARKING LOT

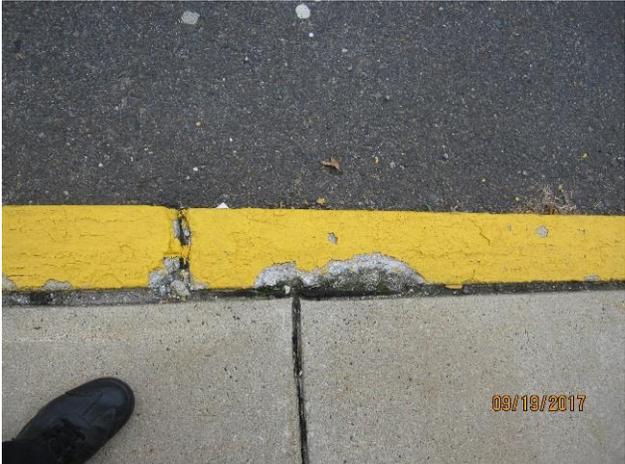
VISIBLE DAMAGE TO CURB

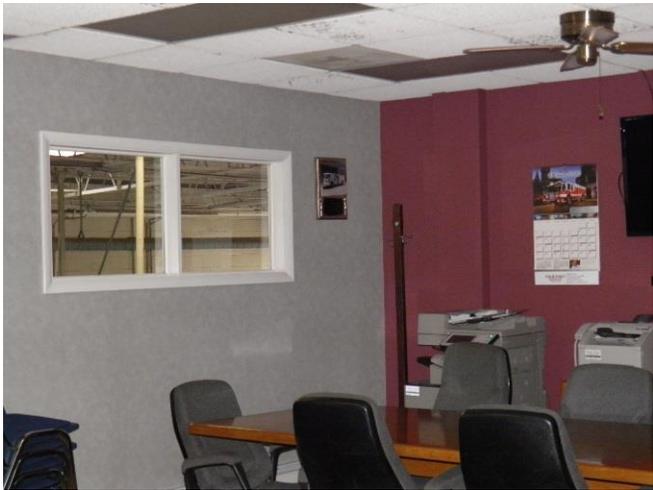
DIRTY CEILING TILES

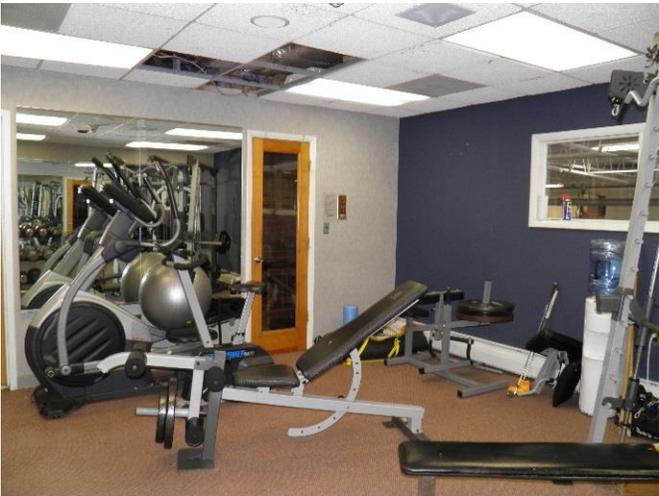
MISSING CEILING TILES

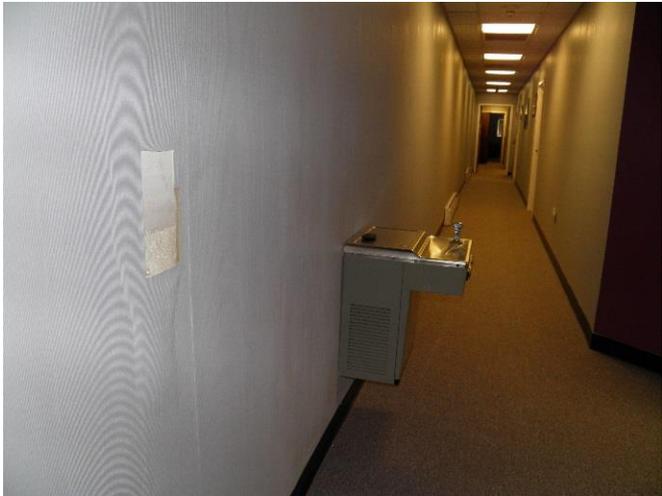
DAMAGED WALLPAPER

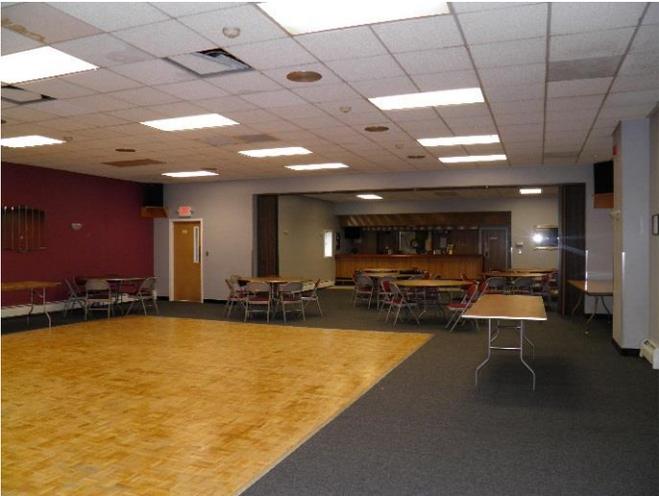
SIGNS OF WATER DAMAGE ON THE CEILING TILES

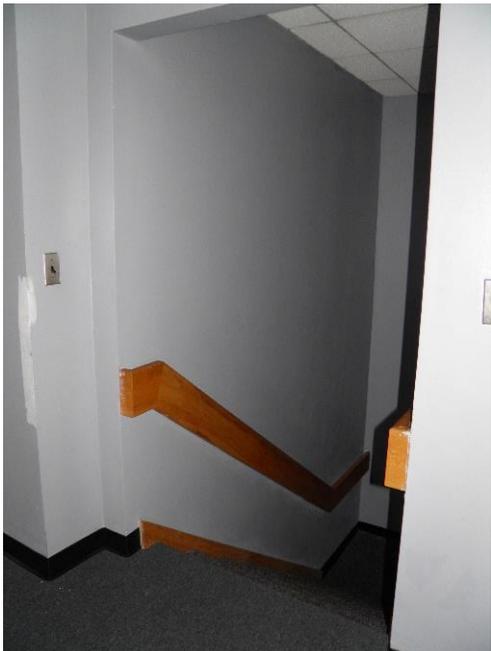
UNFINISHED REPAIR O WALL DAMAGE

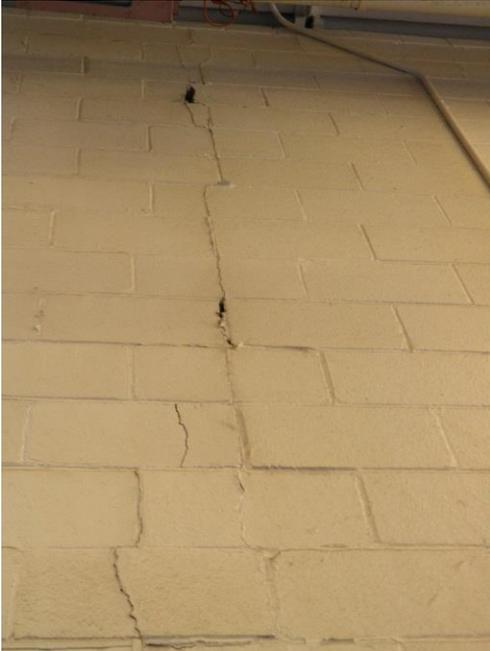
SEVERE CRACK IN THE MASONRY

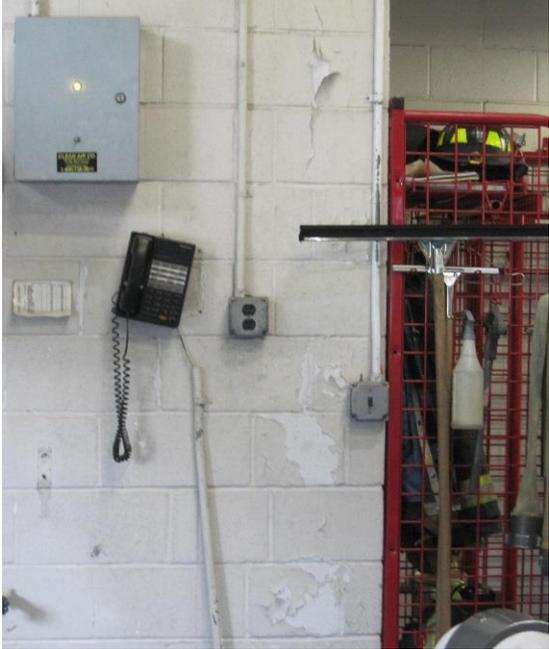
PAINT PEELING FROM WALL

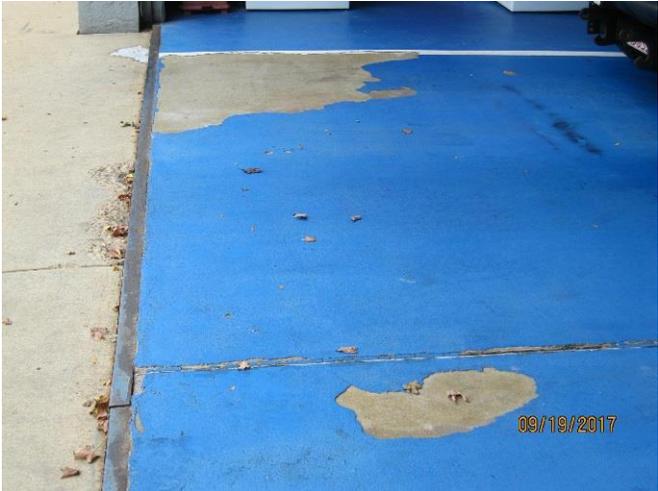
FLOOR PAINT PEELING FROM CONCRETE

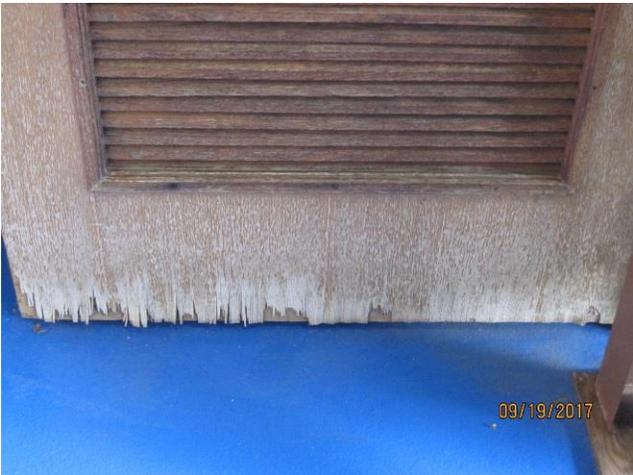
VISIBLE DETERIORATION TO DOOR

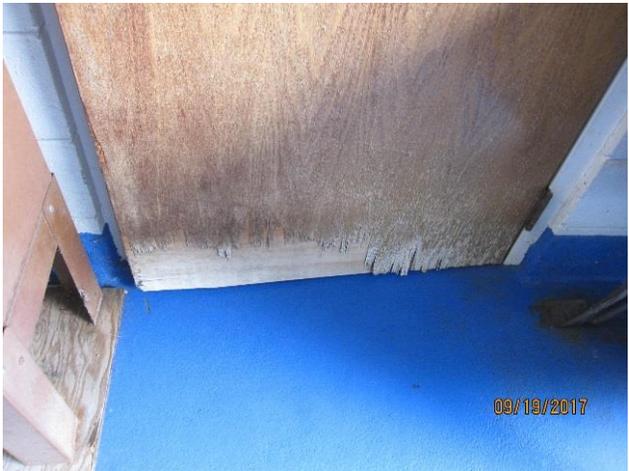
VISIBLE DETERIORATION TO DOOR

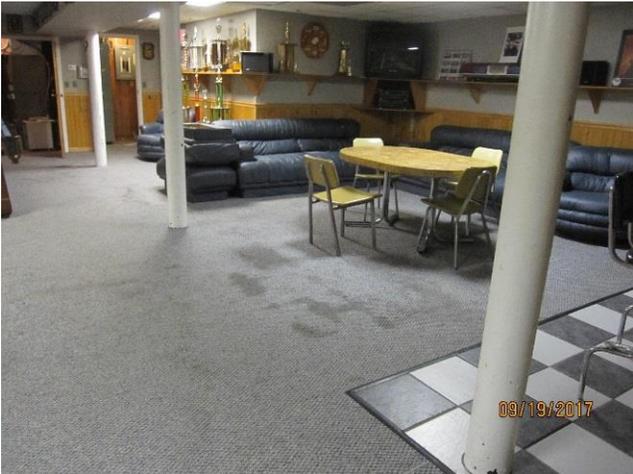
STAINS ON CARPET COULD INDICATE A WATER LEAKAGE

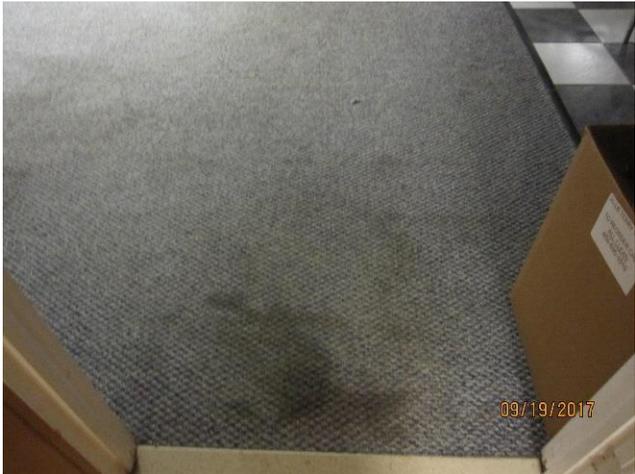
DIRTY CARPET

v. Replace acoustical ceiling tiles in the lounge room	\$650
vi. Replace acoustical ceiling tiles in the banquet hall	\$600
vii. Replace the carpeting in the basement recreation room	\$5,500

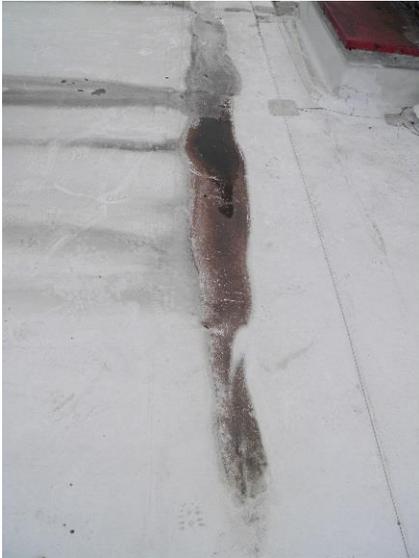
SIGNS OF WATER PONDING

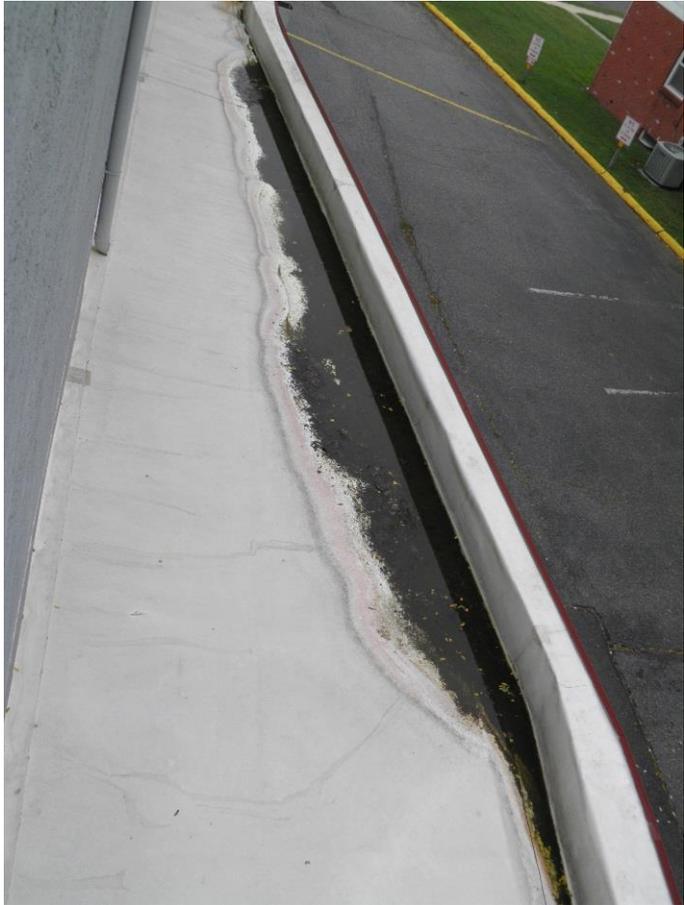
VISIBLE WATER PONDING

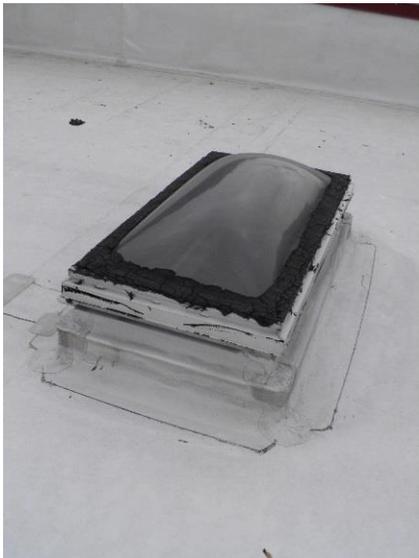
PREVIOUS REPAIR TO STOP WATER INFILTRATION AT SKYLIGHT

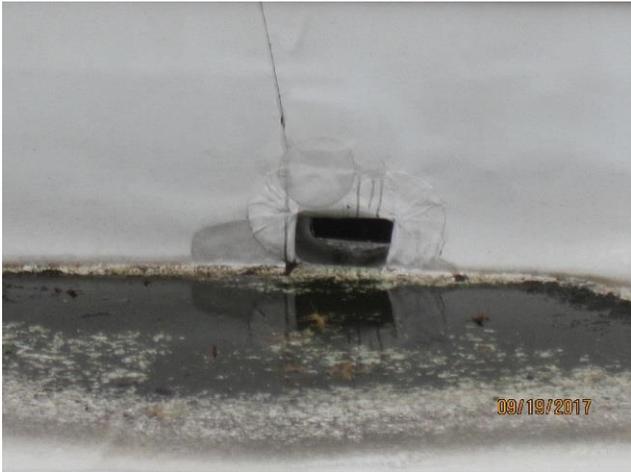
- iii. There are no issues with this façade, the façade received new elastomeric coating in 2015 and is in good condition.
 - iv. There is one roof scupper box that has shifted slightly.

POOR DRAINAGE AT SCUPPER

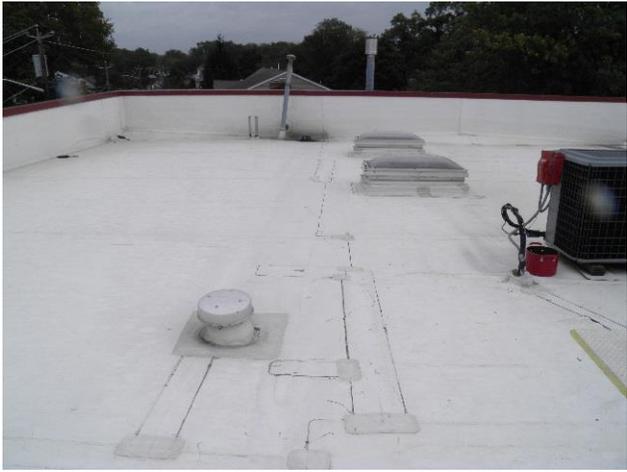
VISIBLE ROOF PATCHES
