HAMILTON TOWNSHIP BICYCLE & PEDESTRIAN CIRCULATION STUDY

FINAL REPORT

NJDOT Local Technical Assistance Program
May 2011

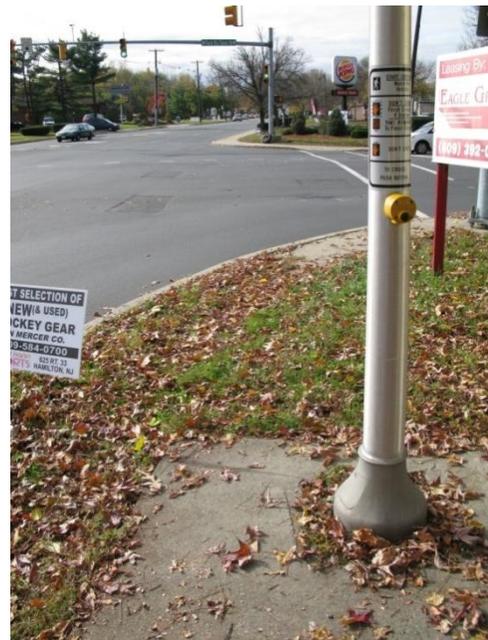
Figure 5 : Missing sidewalk on NW corner

All three standard crosswalks have non-ADA compliant curb ramps at either end. The curb ramps lack detectable warnings, such as a red, textured surfacing, to accommodate pedestrians with poor vision. There is also a sidewalk deficiency on the northwest corner of the intersection which is shown in Figure 5. Though a depressed curb exists, there is no sidewalk along Quakerbridge Road southbound at this corner. A worn path in the grass along the road indicates significant pedestrian traffic, as this crosswalk on the north leg of the intersection is the only pedestrian crossing of Quakerbridge Road. Due to the lack of a sidewalk, the push button control to cross Quakerbridge Road is also not handicap accessible.

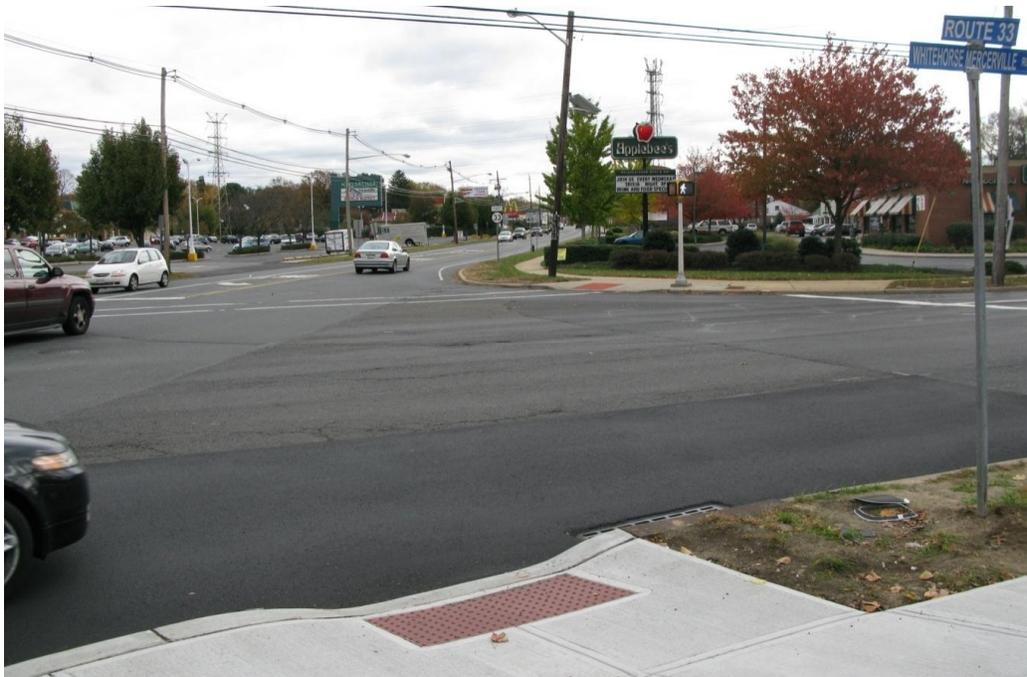
Figure 6: Missing crosswalk; existing curb ramps and pedestrian signals

The main pedestrian deficiency of this intersection is the southern leg crossing Whitehorse-Mercerville Road. This crossing lacks a crosswalk; however, it has been outfitted with ADA compliant curb ramps, pedestrian signals, and countdown timers. This inconsistency creates significant confusion for pedestrians, as well as vehicular traffic, as to whether this leg of the intersection is an appropriate and safe place for pedestrians to cross Whitehorse-Mercerville Road.

Figure 6 illustrates the problems with this leg of the intersection.

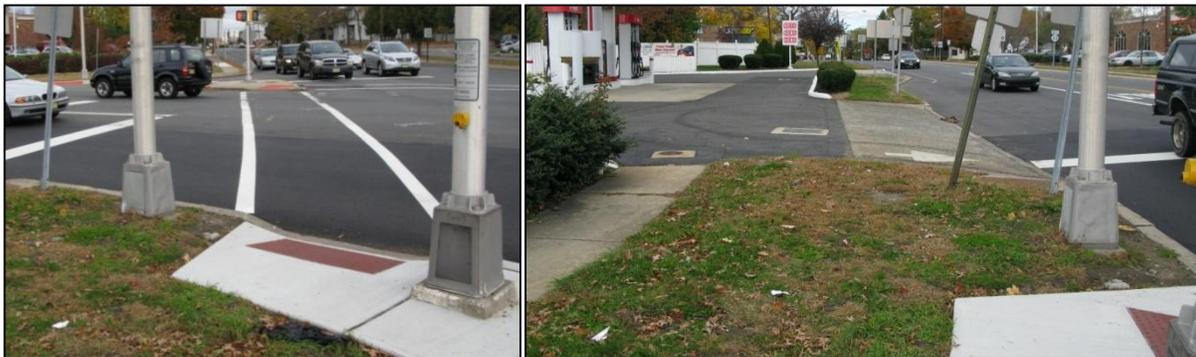
Figure 7: Poor sidewalk alignment and incomplete sidewalk at the southwest corner, near Lukoil station

In addition to pedestrian signals, each corner also has curb ramps. The southwest corner appears to have been recently renovated and is ADA compliant; it incorporates the more current detectable warning system – a red surface with truncated domes. The curb ramps at the other three corners are non-ADA compliant. Though each ramp has a red, slightly textured surface, they lack the more effective surfacing of red truncated domes to aid visually impaired pedestrians, as required by ADA specifications. Each corner has complete sidewalks approaching the crosswalks as well. However, east of the northeast corner, along Route 33 westbound, there is approximately 100 feet of missing sidewalk between the corner and an entrance/exit to the Mercerville Shopping Center. On the southwest corner, the sidewalk is complete, although the route for pedestrians along eastbound Route 33 and attempting to use the crosswalk across Route 33 is a bit indirect and involves a pedestrian refuge, as shown in Figure 7. There is also missing sidewalk in front of the Lukoil station along NJ Route 33 eastbound.

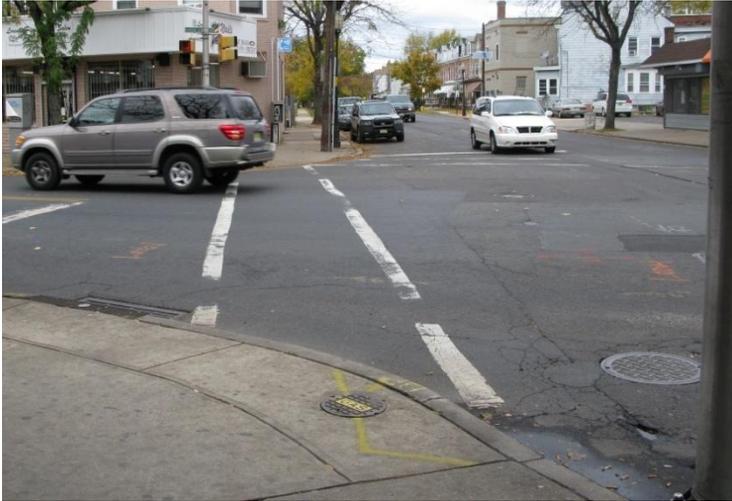
Figure 8: Curb ramp not aligned with crosswalk

crosswalk, as shown in Figure 8. By ADA requirements, at the bottom of a centered curb ramp there must be a 48-inch wide area contained within the crosswalk markings to protect pedestrians from traffic in the intersection after they descend the ramp. This criterion is not met by the current crosswalk striping. Additionally, none of the curb ramps are equipped with a detectable warning surface for visually impaired pedestrians.

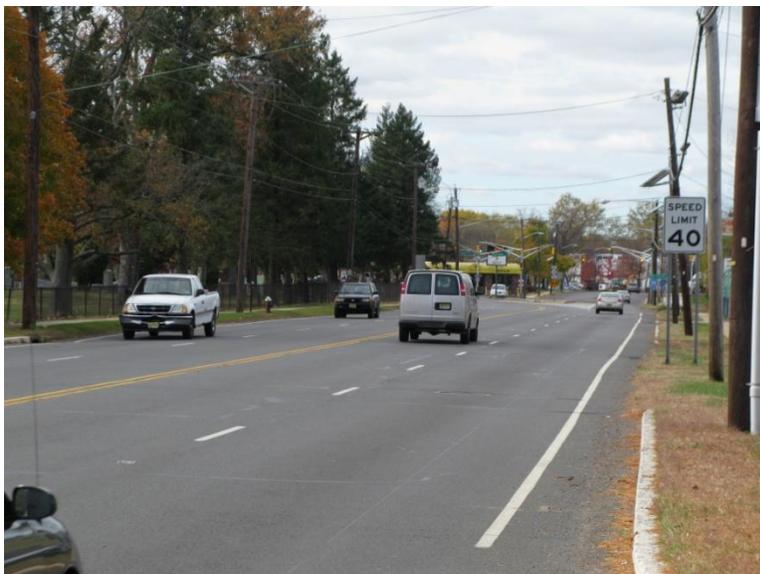
Figure 9: Nottingham Way

Nottingham Way is a four lane roadway approximately 50-55 feet wide with a posted speed limit of 40 mph as depicted in Figure 9. There is a Burger King and a bus stop along this section of the corridor, but otherwise few pedestrian generators. The large shopping plaza along the westbound side is largely vacant.

Regarding bicycle facilities, there is a narrow shoulder (approximately 2-4 feet); however, multiple traffic lanes and scattered sewer grates generally deter bicycle usage. This section is not bicycle compatible.

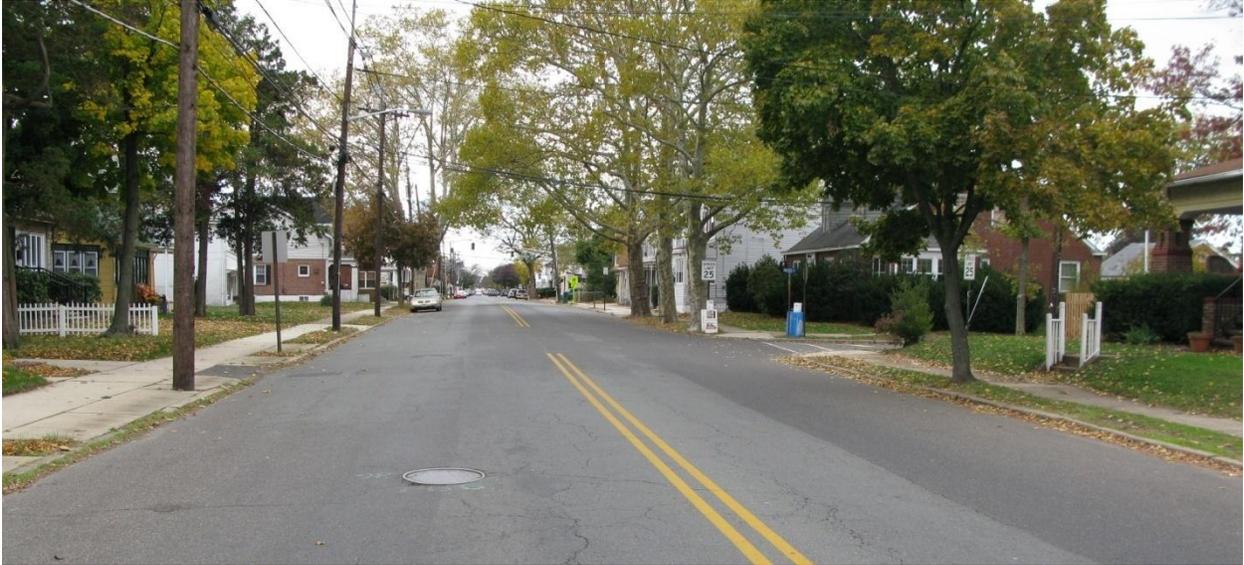
Figure 11: Hamilton Avenue

Sidewalks are generally in good condition and continuous throughout the corridor. Standard crosswalks are present at major intersections and crossings. Curb ramps are generally present at major crossings, but are not ADA compliant due to either missing or substandard detectable warning surfaces for the visually impaired. Pedestrian conditions at major crossings along the corridor are summarized in Table 3. Crosswalks at side streets are generally nonexistent or the striping is badly worn.

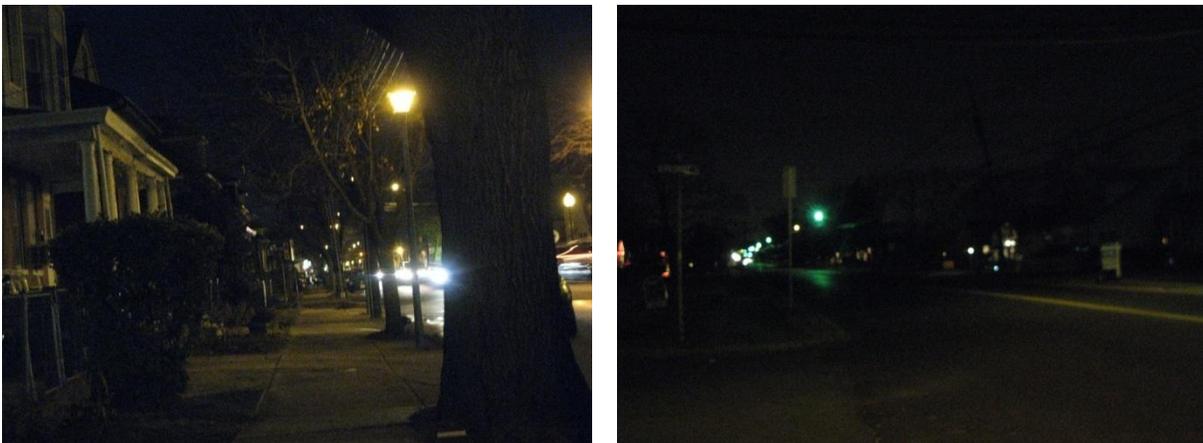
Pedestrian lighting over the more urban western portion of the corridor from Olden Avenue to Francis Avenue is adequate. This portion has both utility pole mounted fixtures and decorative, pedestrian scale lampposts along both sides of the street. There is also moderate ambient lighting from small retail properties along the sidewalks. East of Francis Avenue, however, the corridor becomes more suburban and lighting is low. This section of Hamilton Avenue is lit by scattered utility pole mounted fixtures on both sides of the street. Figure 12 establishes examples of the lighting in these two different sections. Additionally, mature tree canopy along the corridor may slightly reduce the area illuminated by each fixture during summer months. Crossings throughout the corridor are generally poorly lit. Transit stops along the corridor also do not have direct lighting.

Figure 12: Lighting along more urban, western section of Hamilton Avenue (left) with lampposts and utility pole lights; lighting along more suburban eastern end of Hamilton Avenue (right), with widely spaced utility pole lights on westbound side.

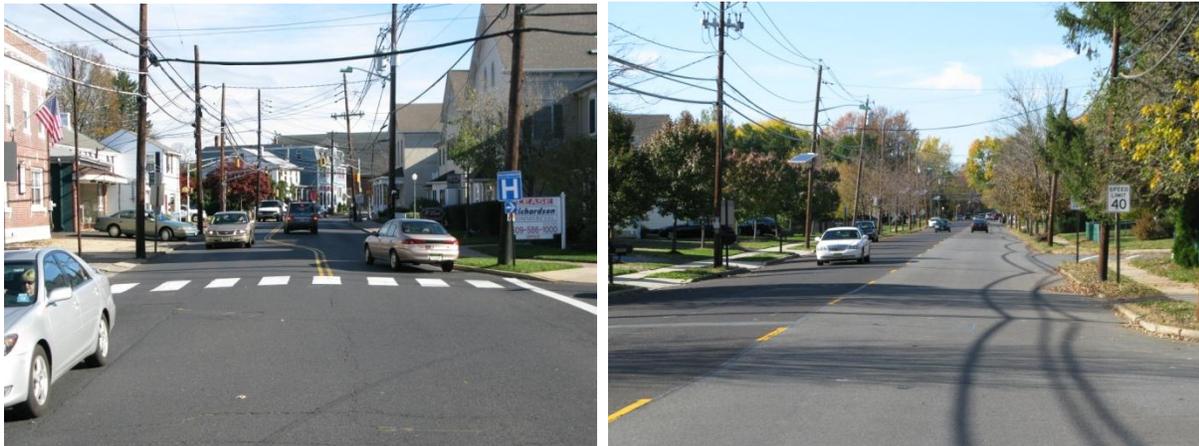
Figure 13: Nottingham Way – vicinity of Hamilton Square (left), typical section (right)

Pedestrian lighting along the corridor is poor. Lighting is provided by utility pole mounted fixtures every few utility poles, but light output from the fixtures is low and not directed at the sidewalks or crosswalks. The majority of the fixtures are on the eastbound side of the corridor. Additionally, a mature tree canopy along the corridor may slightly reduce the area illuminated by each fixture during summer months. Nottingham Way is largely a suburban residential area with minimal ambient lighting. The commercial properties in Hamilton Square are largely closed in the evening and also provide minimal ambient lighting. Crossings along the corridor are also generally poorly lit. The busy intersections in the vicinity of Hamilton Square, in particular, are poorly lit and have minimal additional light fixtures in the area.

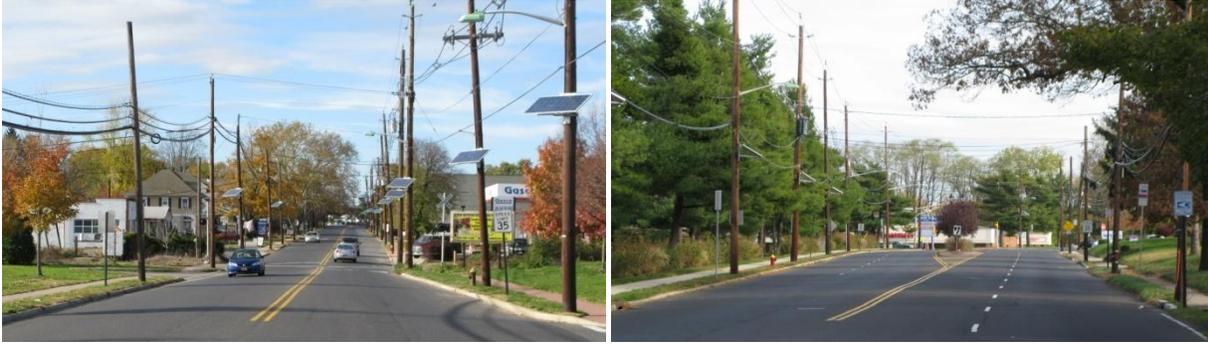
The roadway is approximately 42 feet wide throughout the corridor and has a 35 mph speed limit. Broad Street is generally one lane in each direction with no painted shoulder, Figure 14 (left); however, lane configuration varies in different sections, visible in Figure 14 (right). In the vicinity of the Sunnybrae Boulevard/Kim Valley Road intersection, Broad Street is four lanes with a center median. West of Sunnybrae Boulevard, the two westbound lanes drop to one lane at Argonne Avenue, while the two eastbound lanes drop to one lane farther west at Highland Avenue. The multiple lanes and dynamic nature of the lane configuration make the western half of this corridor incompatible for bicycle activity. East of Sunnybrae Boulevard, however, Broad Street is bicycle compatible. This section is only two lanes and, though it lacks a defined shoulder or bike lanes, the wide lane width can accommodate bicycle traffic.

Figure 14: Broad Street – typical section east of Sunnybrae Blvd (left); multiple lanes west of Sunnybrae (right)

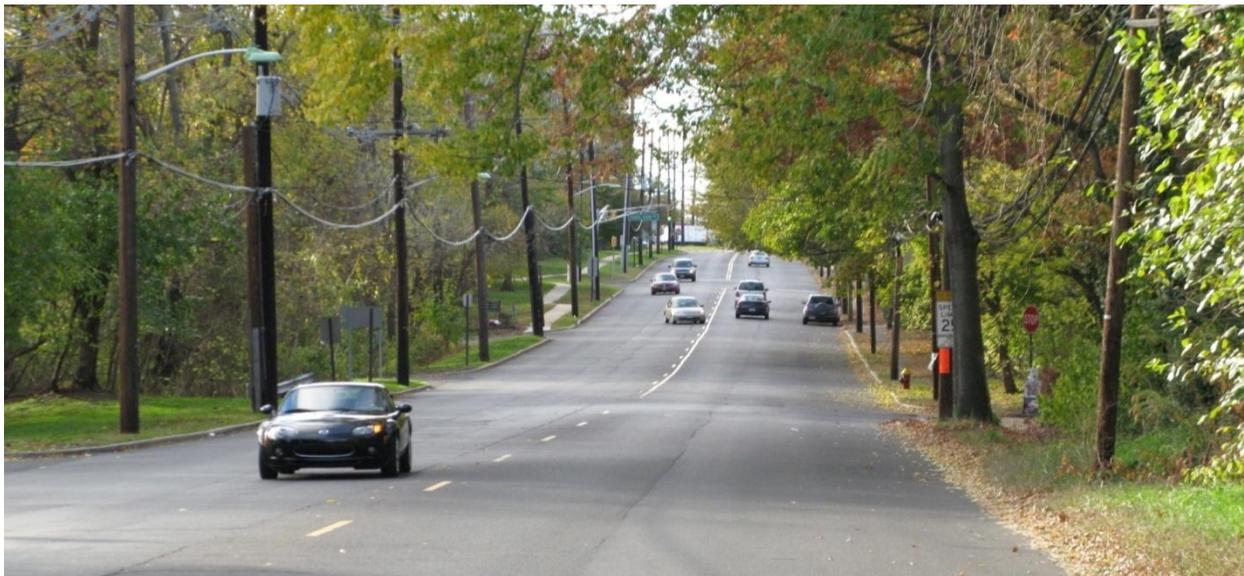
Conditions for pedestrians along this section of South Broad Street are poor. Sidewalks are largely absent on the eastern half of the segment (from approximately east of Gropp Avenue) on both sides of the road (Figure 15). No crosswalks are provided at the signalized intersection on the corridor (intersection with Pebble Creek Drive) and only two of the four corners have curb ramps, which are not ADA compliant. The use of curb ramps at side street intersections is variable; some corners have them while others do not. None of the existing curb ramps have a detectable warning feature for the visually impaired. Additionally, none of the cross streets or major driveways (to apartment complexes or school) have crosswalks.

Figure 15: South Broad Street; sidewalk missing east of Gropp Avenue

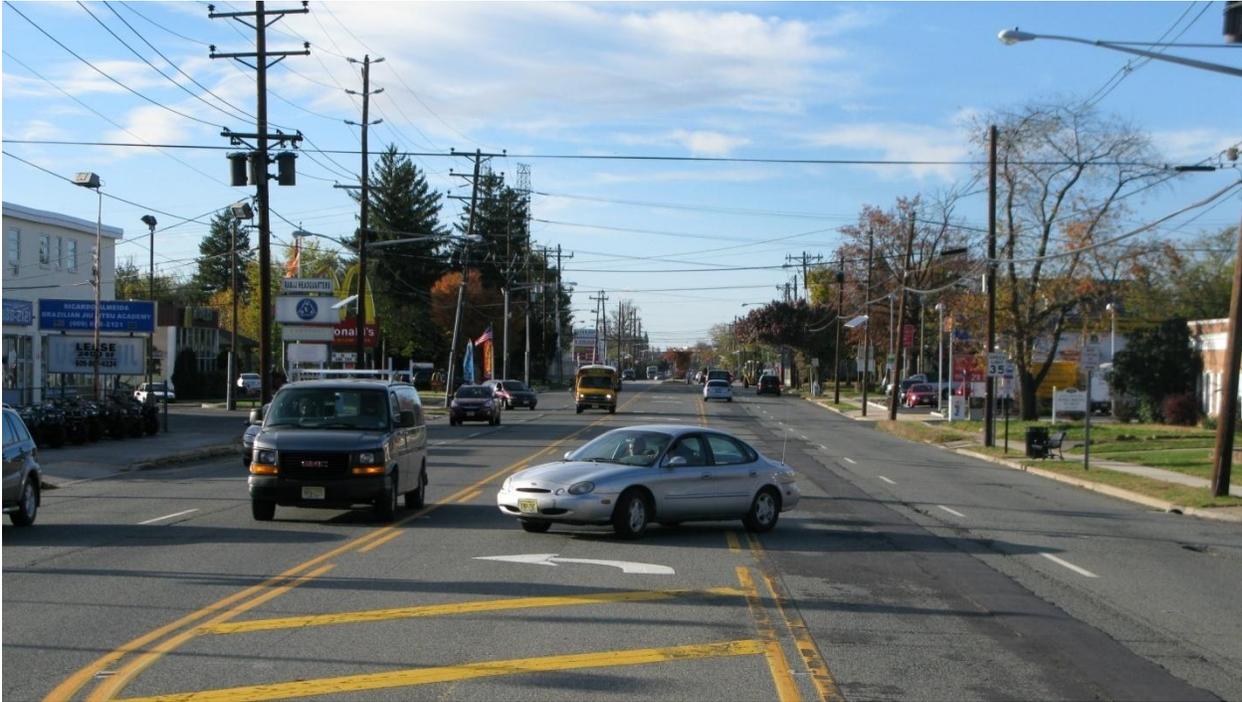
Figure 16: South Broad Street, vicinity of Fetter Avenue intersection

providing sufficient lighting for the sidewalk or shoulder on the opposite side. Lighting is improved by the addition of lamppost fixtures in the median from Whitehorse Circle to Hobson Road; however, the eastbound sidewalk in front of Colonial Memorial Park remains dim. West of Hobson Road, there are no median lampposts to provide additional lighting. The section from Hobson Road to Redwood Avenue is lowly lit. West of Redwood Avenue, there is a larger amount of strip commercial development, which provides some ambient lighting. Lighting at pedestrian crossings is also generally low. Transit stops along the corridor generally do not have direct lighting at the signed bus stops, but have ambient lighting from fixtures in the vicinity.

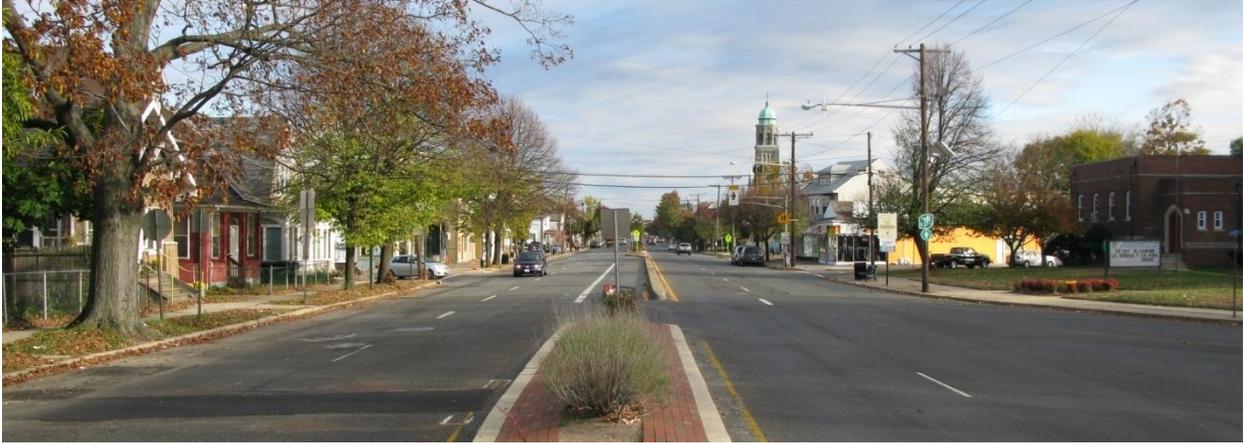
Figure 17: South Broad Street

As with the previous segment, the roadway is approximately 68 feet wide and carries 4 lanes of traffic. Lane width is approximately 15 feet, with an eight foot curbed median through the majority of the segment as evident in Figure 17. The speed limit is 35 mph, dropping to 25 mph toward the western end of the corridor. On-street parking is allowed through much of the segment. This segment also lacks striped shoulders or bike lanes. Although many residential properties have direct driveway access to this segment of Broad Street, shared parking among business has been introduced in some locations, and no two-way-center-left-turn configurations are present. Though conditions for bicycling are improved in this section of Broad Street due to a lesser amount of driveways accessing high use retail properties, the multi-lane configuration and lack of bike lanes or shoulders makes this section incompatible for bike use.

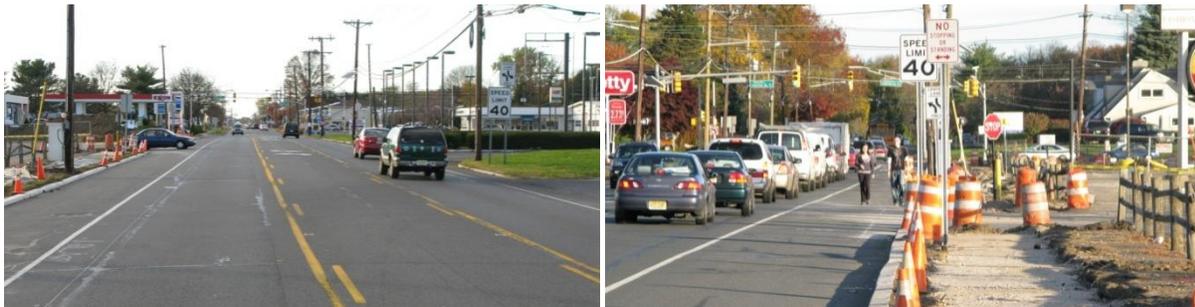
The sidewalk in this section is in poor condition. In the westbound direction, there is no sidewalk on the western half of the block, in front of a defunct car dealership. In the eastbound direction, there is no sidewalk in front of the ShopRite shopping plaza, which occupies the majority of the block. However, construction is in progress to install a full sidewalk along the length of the block in the eastbound direction as shown in Figure 18 (right). Deficiencies will remain in the westbound direction.

Figure 18: Route 33 (left); sidewalk under construction in eastbound direction, pedestrians using the shoulder (right)

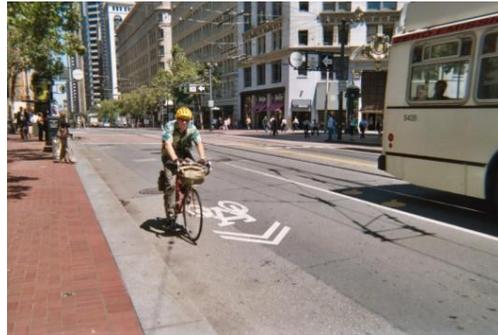
Pavement markings that indicate a shared lane environment for bicycles and automobiles. Shared lane markings, or "sharrows," indicate the presence of a bike route and tell motorists where to expect a bicyclist's travel path. Shared lane markings encourage bicyclists to travel outside the door zone and remind cyclists to ride with traffic, not against it. Sharrows may be utilized where road width is too narrow to accommodate a bicycle lane, within single or multi-lane roundabouts, and along front-in angled parking where a bike lane is undesirable.

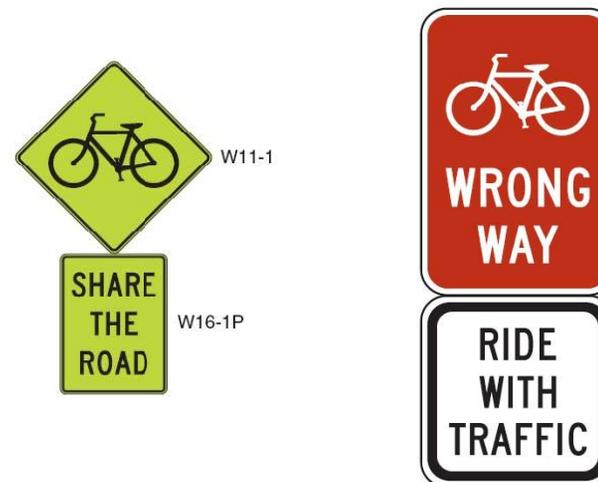
The following signs are standard ways to alert motorists to shared lanes and are included in the national Manual on Uniform Traffic Control Devices (MUTCD).⁴

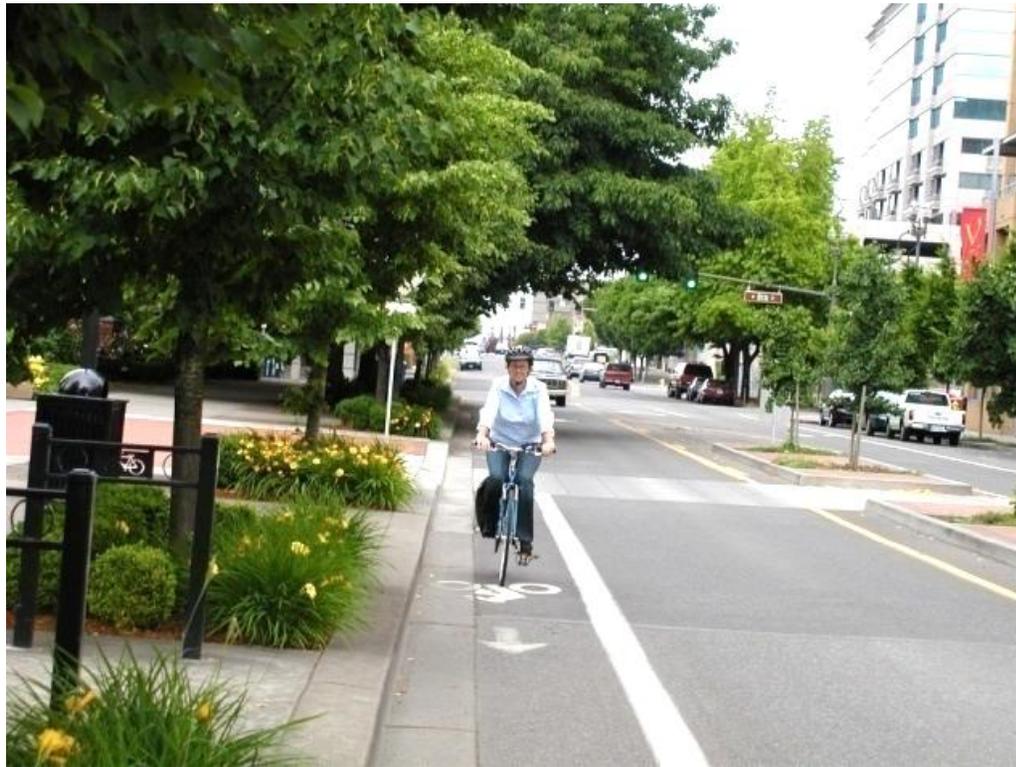
A dedicated bicycle facility delineated by striping, signage and pavement markings adjacent to the motor vehicle travel lane. On-street lanes alert motorists to the presence of a bike route and allow bicyclists to use the street with less interference from traffic. Bike lanes typically run in the same direction as motor vehicle traffic, but may be configured in a

contra-flow direction for short distances on low-traffic corridors where bike route connectivity is needed. Lanes typically run along the right-side of the street, but may be placed on the left side of one-way streets to reduce conflicts with parked cars, buses and right-turning vehicles. Two-way bike lanes should be placed on the left side of a one-way street.

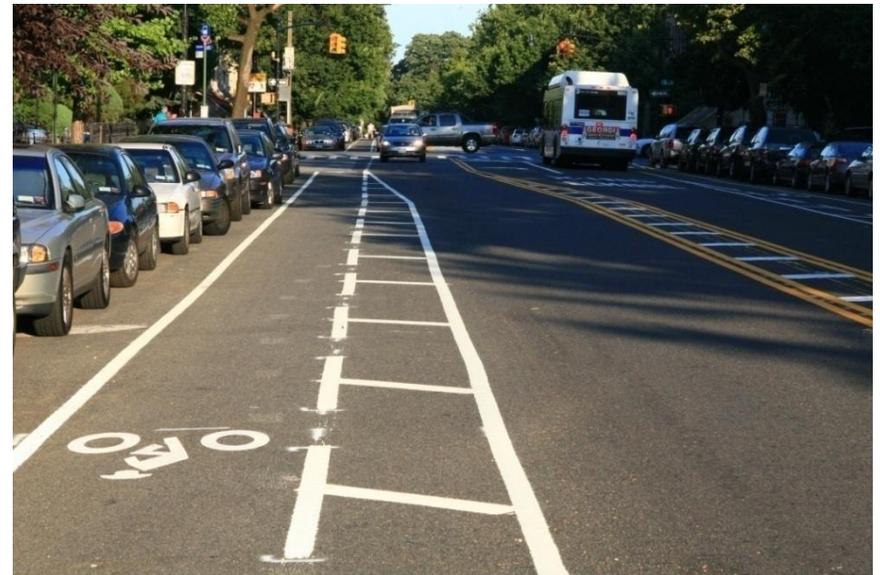
Buffered Bicycle Lane

A conventional on-street bicycle lane with a designated buffer space separates the bicycle lane from motor vehicle travel lanes and/or parking lane. The buffer provides greater shy distance between bicyclists and passing motor vehicles and encourages bicyclists to travel on towards the left side of the lane which is outside the door zone.⁷

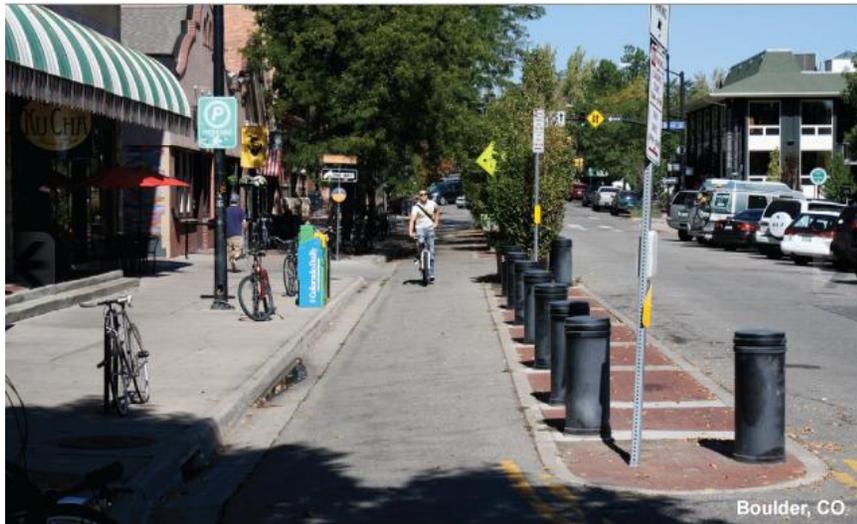
Cycle track buffered by trees

Bicycle facility that is separated from motor vehicle travel lanes by bollards, parking, curbs and/or medians. Cycle tracks can be one-way or two-way, placed on one or both sides of a street. Two-way bike lanes should be placed on the left side of a one-way street. Where on-street parking is present, the cycle track is placed between the parked vehicles and the sidewalk, reducing the risk of conflict between bicyclists and car doors. Major intersections should be signalized with separate cycle track signal phases and cycle track crossings should be marked to increase their visibility. Cycle tracks should be marked in the same manner as bicycle lanes.

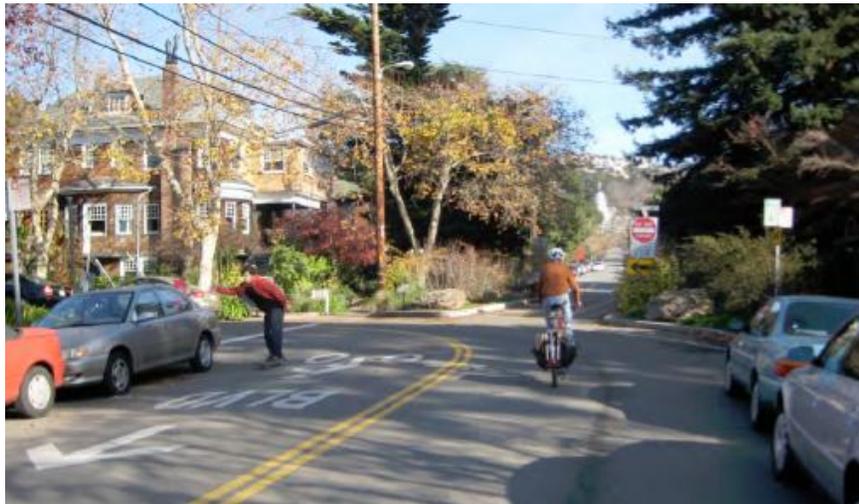
A roadway that prioritizes bicycle traffic over motor vehicle traffic. Bicycle boulevards are distinguished with uniform signage and pavement markings that identify the street as a shared space. Traffic calming measures are often used to maintain low motor vehicle volumes and speeds. Non-local motor vehicle traffic is discouraged from using bicycle boulevards through diverters, such as partial street closures and forced right-turn treatments, which direct motorists to nearby arterial routes, but allow bicyclists to continue through.

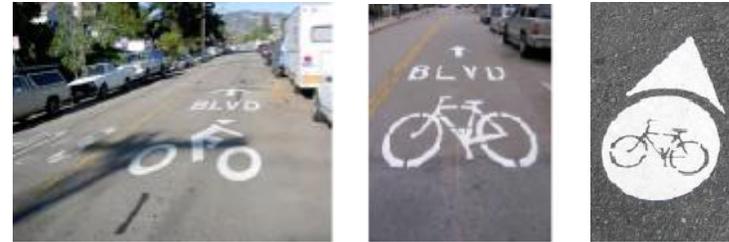
Pavement Markings Examples:

Install bike boulevard markings after each intersection and at intervals of approximately 200 feet. Sizes range from 1 ft by 2 ft to 6 by 30 feet and can be applied with paint or thermoplastic, which has a longer lifespan.

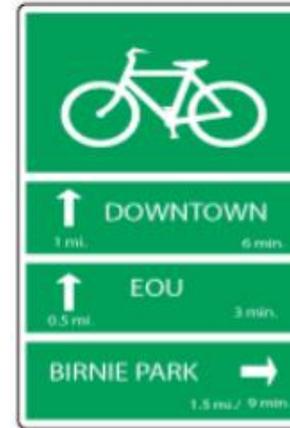
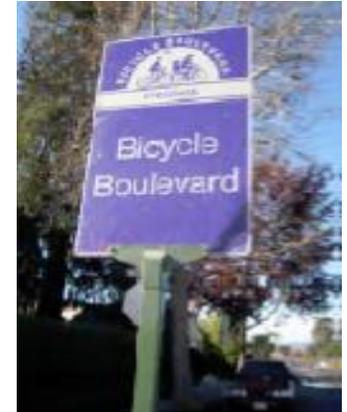
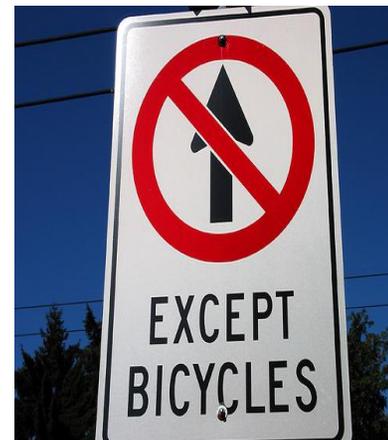
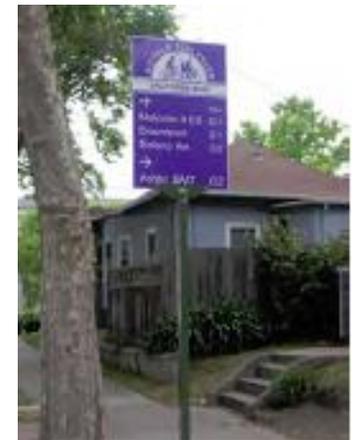
Signage Examples:

- Identification Signs - place as needed at major intersection to inform all roadway users that the street is a bicycle boulevard
- Wayfinding Signs - place as needed at intersections and mid-block locations to direct cyclists along bicycle boulevard. Also can provide information to major destinations
- Traffic Control (signals and signs) - install as needed to regulate traffic at intersections and to prioritize traffic flow along the bicycle boulevard

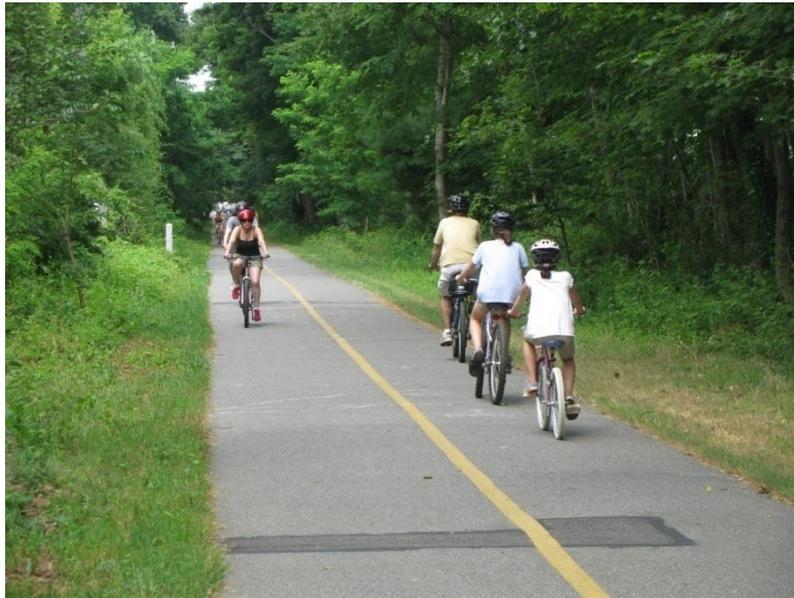
A bike path or trail⁸ is physically separated from motor vehicle travel lanes by an open space or barrier. Paths and trails are typically designed for two-way travel.⁹ Intersections and crossings require specific bicycle treatments such as signals, signs and striping. It is important to establish priority (for cyclists or drivers) in the design of the junctions and to accommodate cyclists riding with traffic and those using the crosswalk to cross.

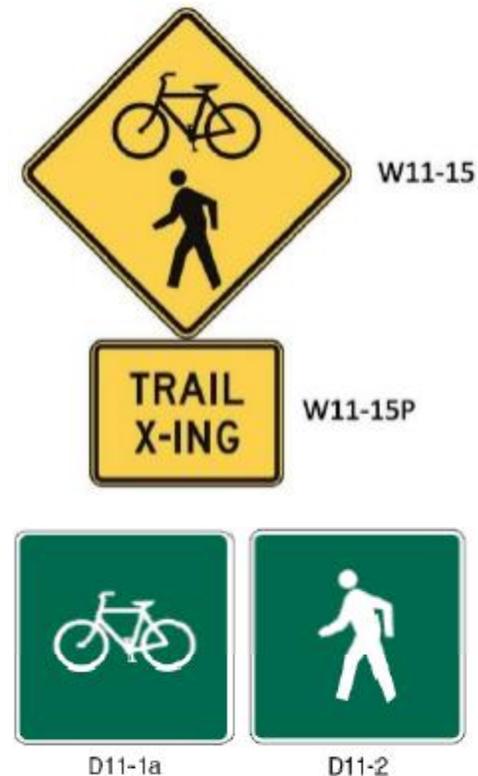
Signage Options for Shared-Use Paths

Following are examples of some regulatory signage.

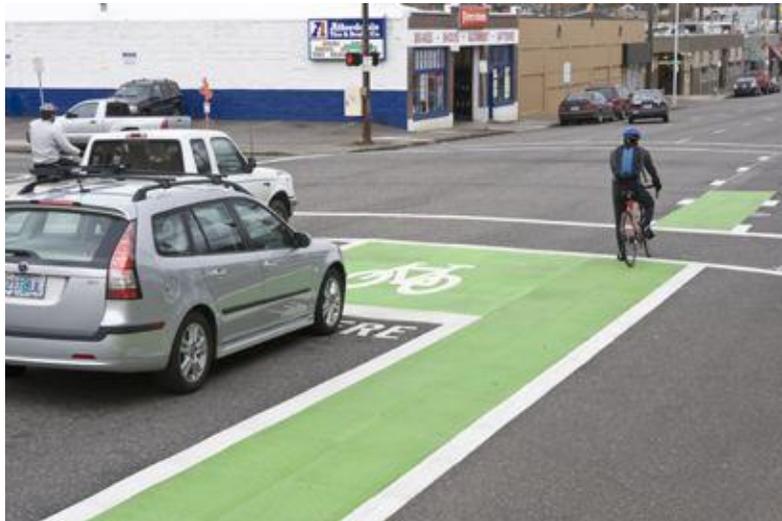
1. Advanced Stop Line/Bike Box

A designated area at a signalized intersection where bicyclists pull in front of waiting traffic during the red signal phase. The bike box is designed to reduce conflicts with motor vehicles by allowing bicyclists to position themselves more visibly and to get a head start through the intersection when the traffic light turns green. If extended across all travel lanes in a given direction, bike boxes can assist bicyclist making left turns and transitioning from a right-side bike lane to a left-side bike lane. Bike boxes can be utilized in conjunction with bike signals.

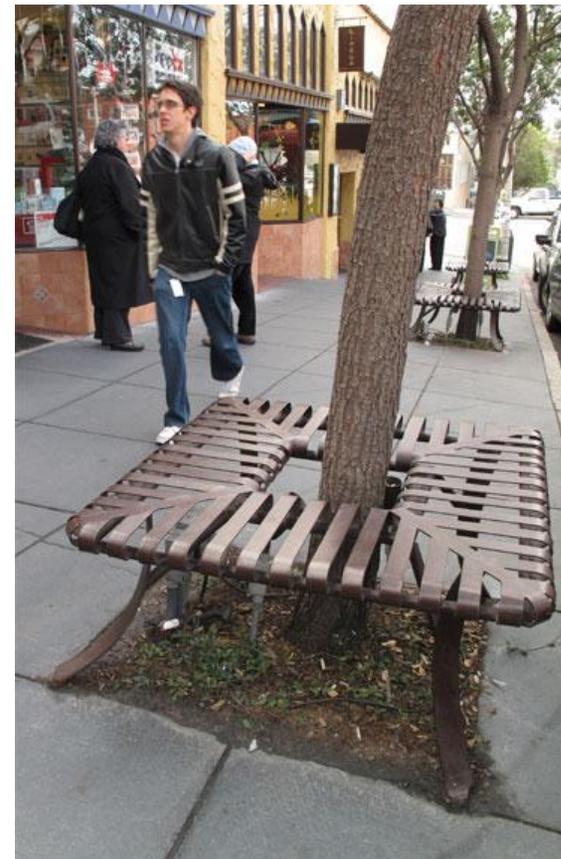
The furnishing zone, also known as the furniture zone, is the place where pedestrian amenities and street infrastructure are placed. This zone can be paved or planted. When right-of-way is available, the furniture zone should be increased beyond the standard size.

Furniture/Planting Zone Variations	
Standard	2 ft
Residential Area	2.5 ft
On-Street Parking Present	3 ft-can overlap some with Edge Zone
Commercial with Ground Floor Retail	3.5 ft
Areas with a lot of snow	6 ft

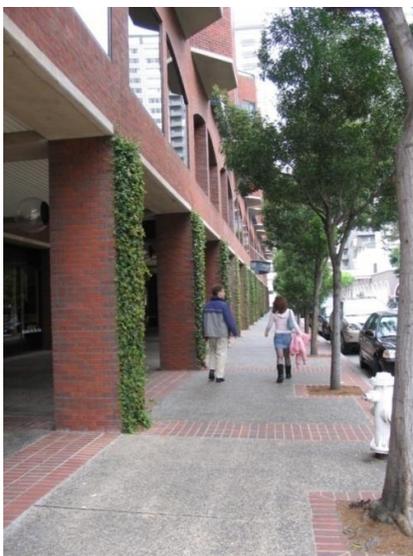
Throughway Zone

The throughway zone is the place for pedestrian travel. It should be completely free of obstacles and protruding objects, and should be at least 5 ft wide with enough space for two pedestrians to walk side by side comfortably. In commercial zones, the throughway zone should be 6 feet wide. The pedestrian zone should never be less than 3 feet; this is the width required to meet ADA guidelines for the “minimum needed for accessible travel.”¹⁰

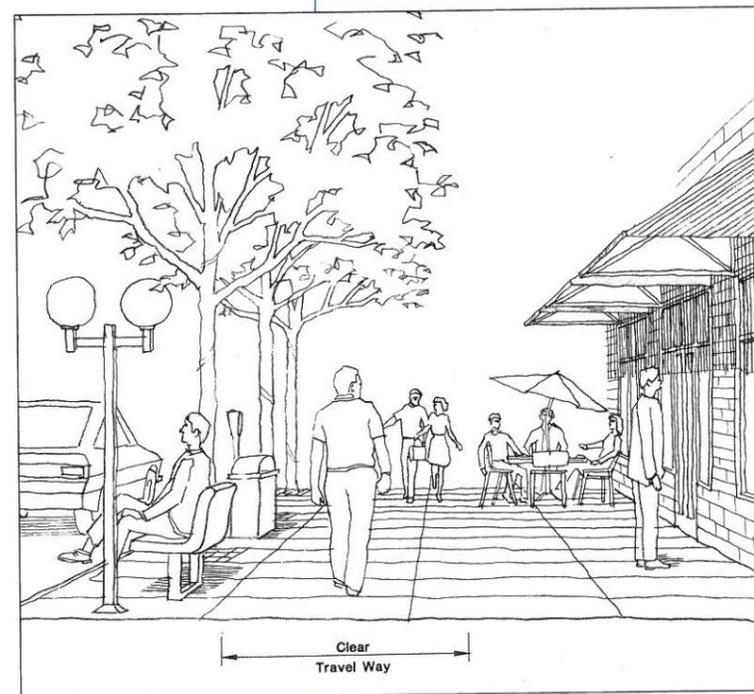
An important concept of the throughway zone is the effective width of the traveled way. People do not walk right up against a tree or a building, thus the useable portion of the sidewalk is net of the “shy distance” people leave between themselves and objects in the furnishing and frontage zones.

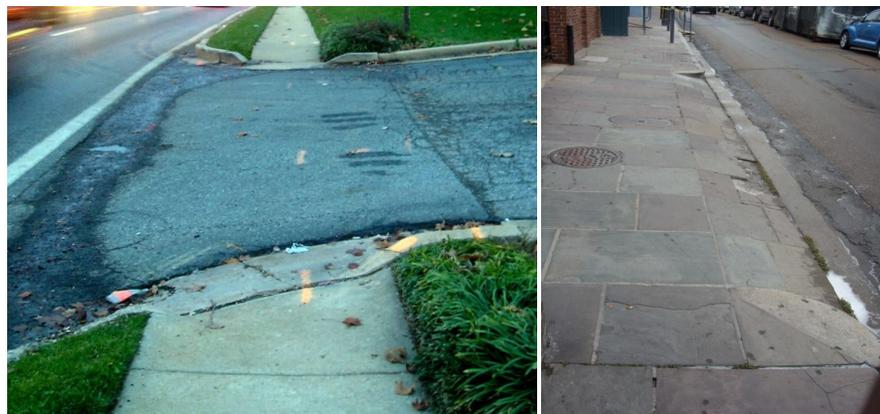
Driveways provide access in and out of private property. The driver is required to yield to pedestrians; however, that does not always happen, in large part due to the design of driveways. The number of driveways should be minimized, with one driveway providing access to several businesses. This is a concept called “access management.” Driveways should not be located near intersections or at bus stops. The New Jersey Department of Transportation recommends driveways at a minimum of 100 feet from the curb cut in the vicinity of signalized intersections on a 35 mph speed limit road.¹¹ When driveways are installed, the sidewalk material should be dominant over driveway material, as shown below. The area should also be maintained at sidewalk level so that people do not have to walk up and down and so that drivers are slowed by the ramp as they enter the driveway. This is consistent with ADA guidance.¹²

This driveway is sloped and dominant over the sidewalk

This driveway ramps up to sidewalk level & uses sidewalk material

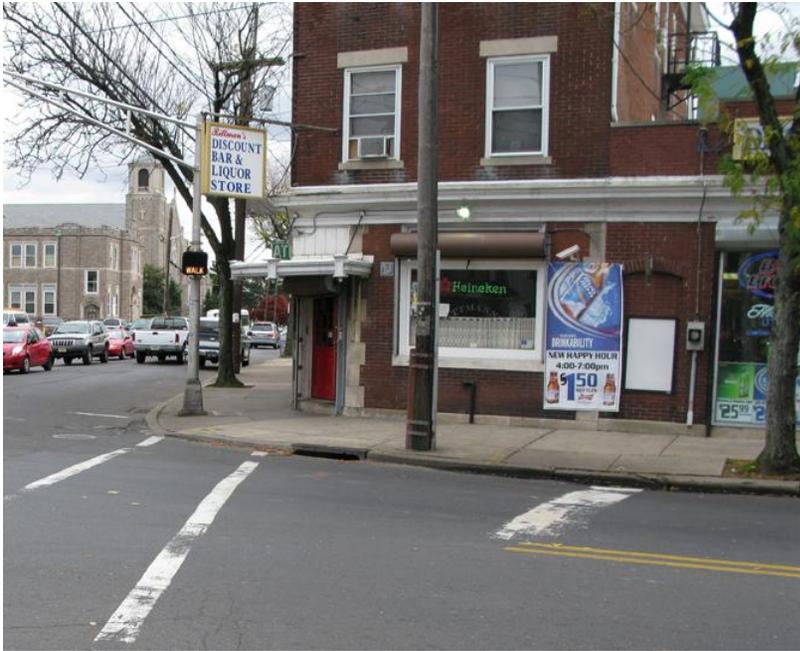
Frontage zone where property line abuts sidewalk

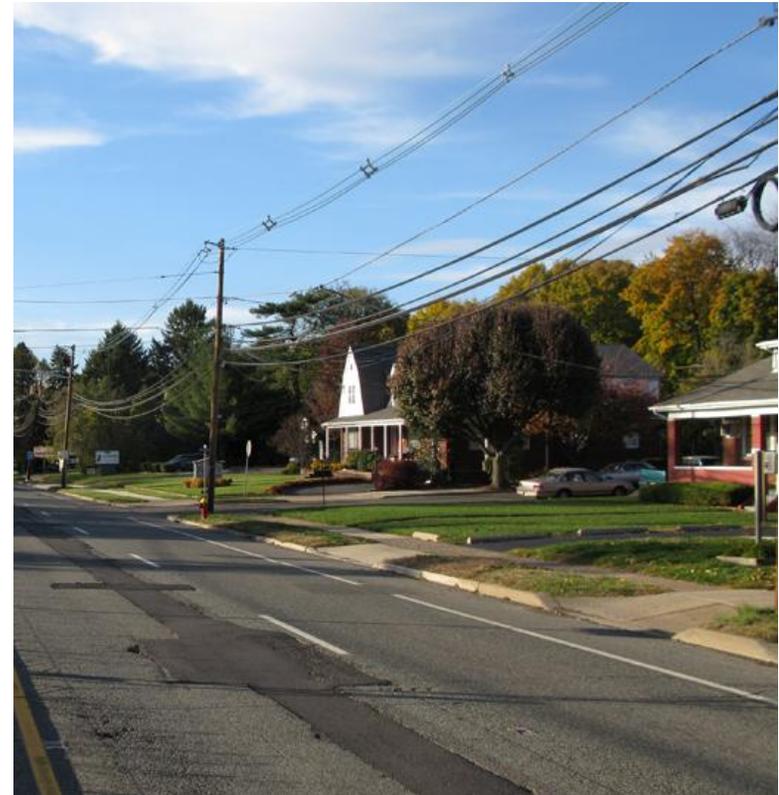
Wider frontage zone in more suburban areas

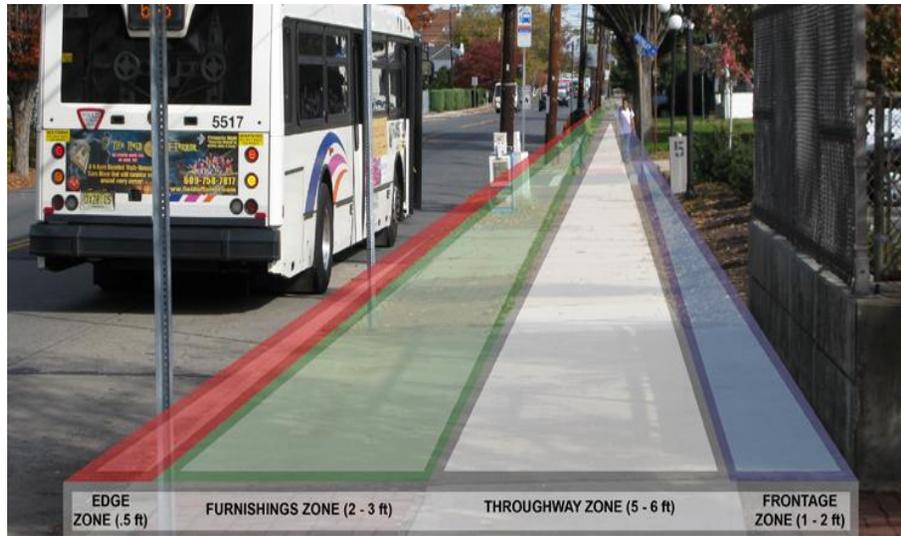
Sidewalk zones in Hamilton

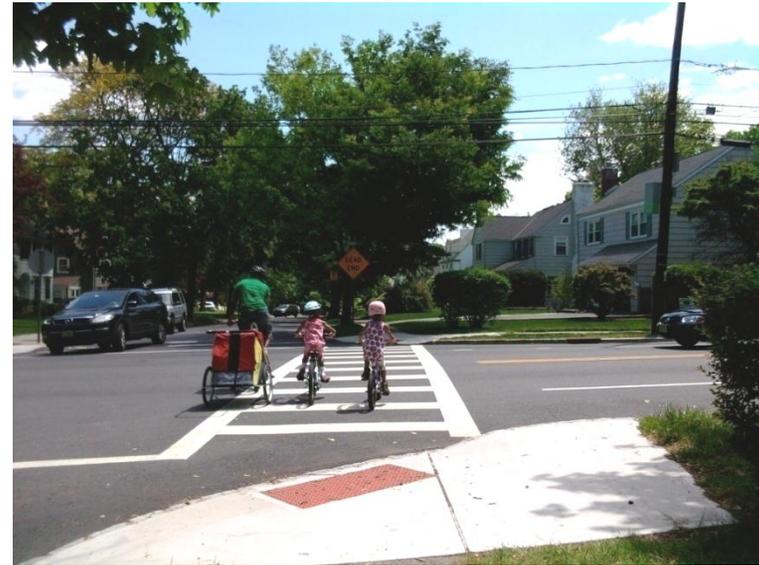
Ladder style crosswalks have been shown to be the most visible to motorists. While lines are striped at a 90 degree angle to the crossing line. The crossing lines should be aligned with the most direct pedestrian crossing. Each line should be 6-24 inches wide and spaced 12-24 inches apart. The line length should be at least 6 feet minimum at all locations and 10 feet in commercial areas or places with high levels of pedestrian activity. Other styles included in the MUTCD are parallel lines and zebra markings. Crosswalks should not be used at uncontrolled locations where speeds are 40 mph or greater. Crosswalk striping should always be white. Vehicle stop lines should be set back at a minimum of 4 feet and optimally at least 10 feet from the end of the crosswalk at signalized locations. At uncontrolled multi-lane locations, stop lines should be set back 20 to 50 feet. The vehicle stop line should be painted at a width of 1 to 2 feet wide across all approach lanes. Align with sidewalk.

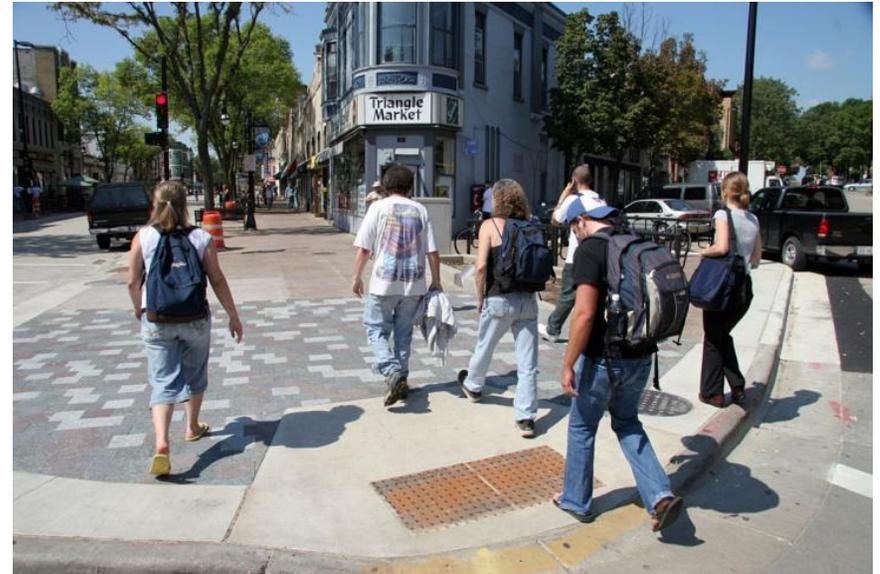
Curb Ramps provide the transition from the sidewalk to the street, and benefit all users, especially those in wheelchairs, people pushing

strollers or luggage, and children on bicycles. There are four basic elements to curb ramp design.

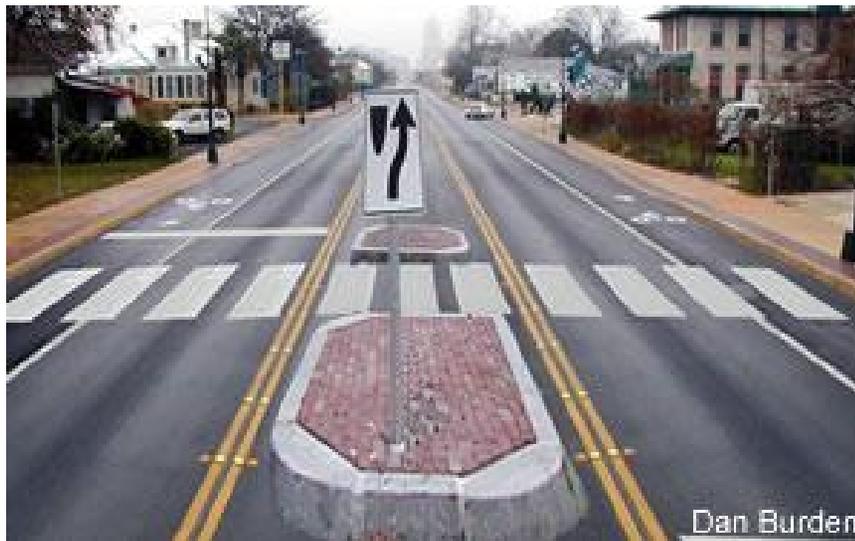
Pedestrian refuge and curb extensions are tools that shorten the pedestrian crossing and decrease the amount of time that someone walking is exposed to someone driving. Curb extensions should be used whenever on-street parking is present. Pedestrian refuge can take the form of medians running down the length of the road or as crossing islands. Both tools can be used at intersections or midblock. Curb extensions provide several benefits, including increasing the visibility of pedestrians waiting to cross. Medians and refuge islands should be at least 8 feet wide, with a minimum of 6 feet, but only after other cross-section elements (lane widths, on-street parking) have been reduced or eliminated.

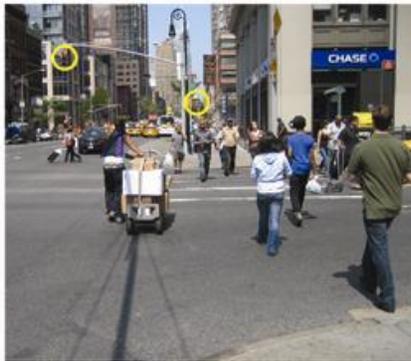
Crashes between vehicles and pedestrians are often caused when drivers make turning movements. Leading Pedestrian Intervals, or LPIs, build in five or more seconds of WALK time at the beginning of each cycle so pedestrians can establish themselves in the crosswalk and reinforce vehicle yielding behavior.

The following diagram shows how an LPI works for the northbound vehicle movement at the intersection photographed. In the photo on the left, the pedestrian WALK sign has gone on, but the vehicle signal remains red. In the second image, drivers turning right yield to pedestrians in the crosswalk. Once pedestrians clear, turning drivers are clear to go.

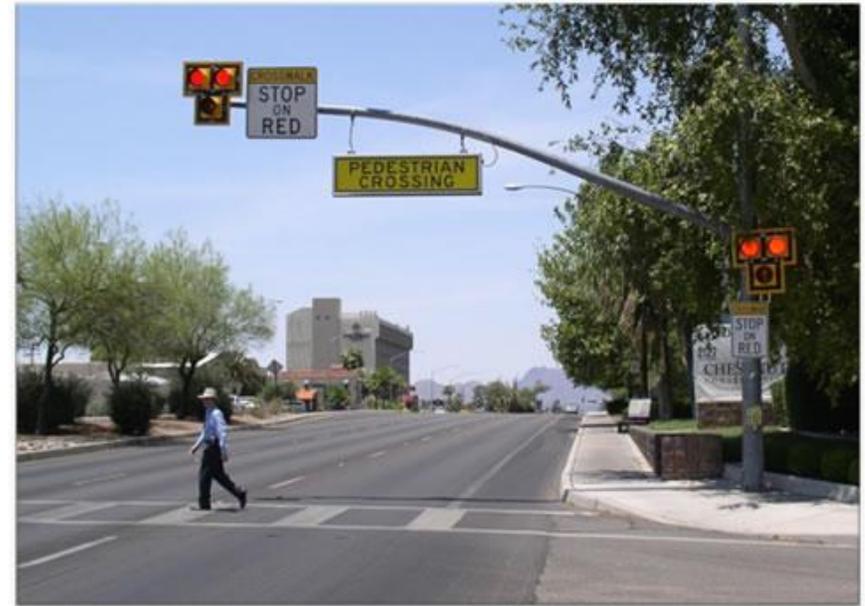
HAWK Operations

HAWK is a special subset of the signal set called a “pedestrian hybrid” signal. It is a signal actuated by a pedestrian, but unlike traditional actuated signals, the pedestrian receives immediate confirmation that her presence has been detected. The images below show how the HAWK signal operates to both drivers and pedestrians. The signal warrant for a HAWK is much lower than for a full signal. A HAWK is warranted if volumes of 20 pedestrians per hour are observed during the pedestrian peak time.
