HAMILTON TOWNSHIP BICYCLE & PEDESTRIAN CIRCULATION STUDY

FINAL REPORT

NJDOT Local Technical Assistance Program
May 2011

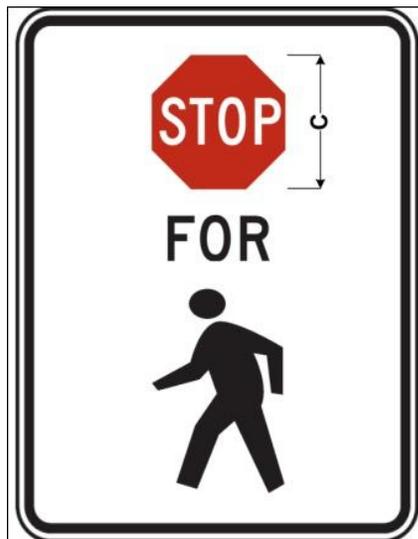
Signing Examples

MUTCD has a variety of regulatory and warning signage to alert motorists to the presence of pedestrians. As of April 2010, the law in New Jersey required motorists to stop for pedestrians in crosswalks. Signage that is being used by NJDOT is shown below. These signs should be placed liberally to educate motorists and enforce the new behavior.
