Hamilton Township Fire Dist. 4  
Fire Engine #14  
1085 East State Street, Hamilton, NJ 08609

## Feasibility Study

December 7, 2017

## **Fire Station # 14, Hamilton District 4 – Audit**

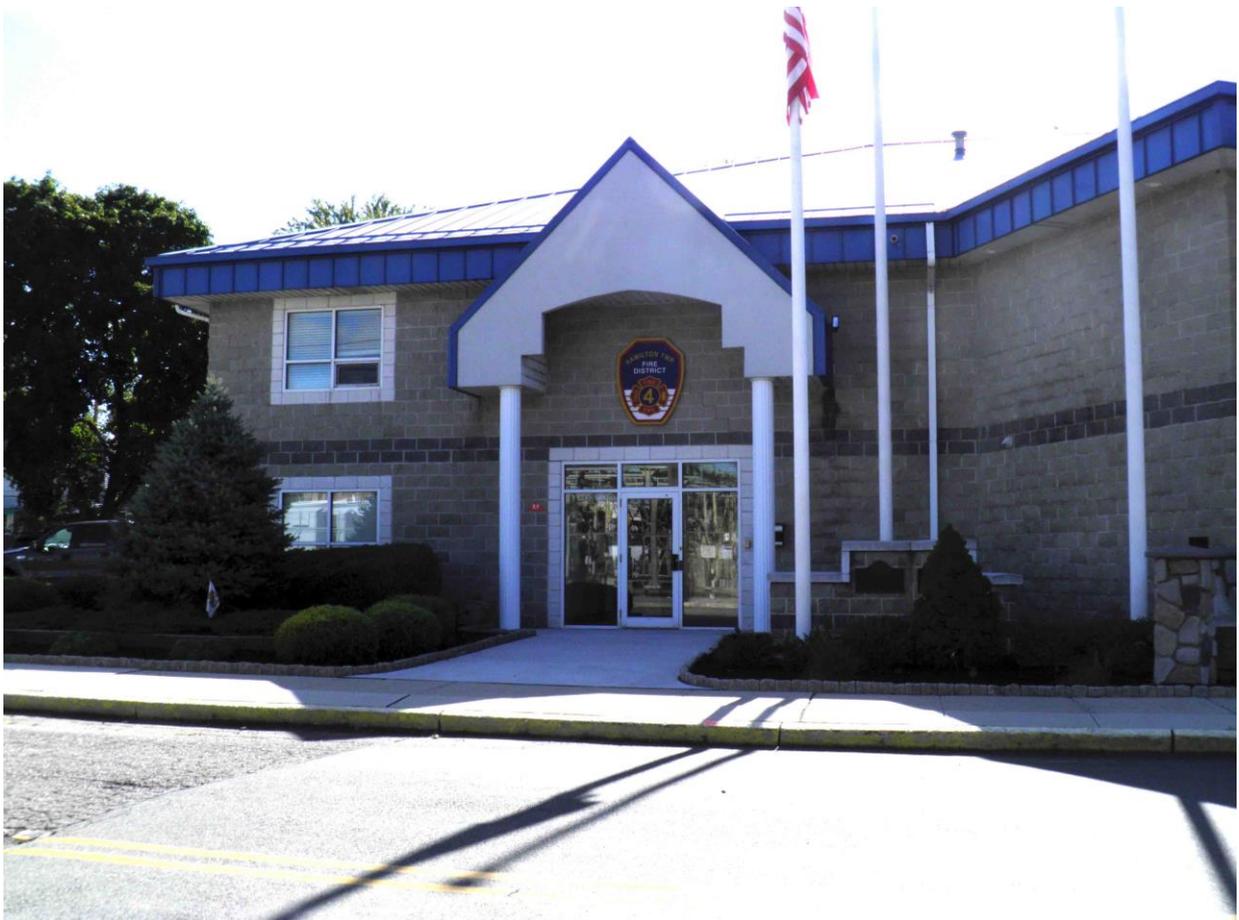
- A. The concrete apron at the (3) truck bay entrance is in good condition. However the concrete curb located between the apron and street is in poor condition containing many spalls and cracks.
- B. The concrete apron at the fourth currently unused truck entrance bay is in fair condition with one crack. The concrete curb located between the apron and street is in poor condition containing many spalls and cracks.
- C. The asphalt parking lot has a few cracks but is in fair condition.
- D. There are designated parking lot barrier free parking spaces.
- E. The station has barrier free entrances.
- F. There is a crack in concrete sidewalk along Hubert Ave.

VISIBLE CRACK IN THE SIDEWALK
